Memorandum

To: Kirsti Bischofberger, Watershed Manager, Municipality of Anchorage
From: Janie Dusel, PE
Date: February 3, 2017
Re: 2016 Low Impact Development/Green Infrastructure Performance Monitoring

The purpose of this memorandum is to provide a summary of the 2016 Low Impact Development (LID) /Green Infrastructure (GI) performance monitoring completed by AWR Engineering for the Municipality of Anchorage (MOA).

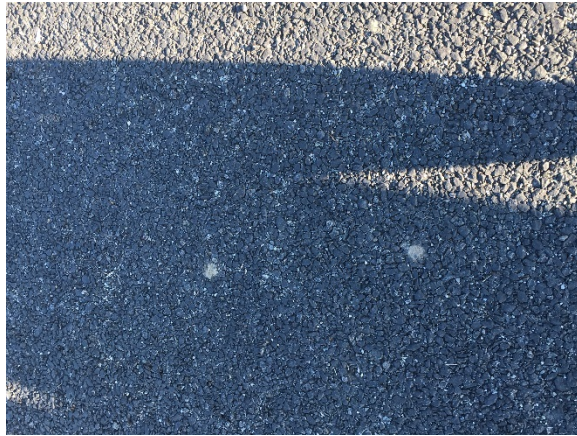
Figure 4: RJSP Parking Lot July 17, 2016

2016 Observations. In addition to the September 22 site visit, this site was visited on July 17, when no precipitation was occurring. Previous monitoring reports (2013 through 2015) have noted positive performance of this parking lot despite ongoing maintenance concerns, particularly with the porous asphalt. The 2016 observations continue this general trend. When the parking lot was visited on July 17, it was observed to be scattered with clumps of dirt and debris which were believed to be tracked onto the parking lot during construction of the Park's new skate park, just north of the parking lot. The parking lot also appeared to have been sanded during the winter and had not been swept. Sanding of the porous asphalt portions of the parking lot is not recommended unless frequent vacuum sweeping is completed. It appeared that sand had been placed on the two smaller portions of porous asphalt, and had been tracked throughout the parking lot. Sand, dirt, and organic debris on the porous asphalt can result in clogging of the asphalt pores, particularly without frequent vacuum sweeping.

One area of the parking lot was also observed to be deeply rutted, potentially from construction support trucks accessing the skate park. Based on the expected parking lot use provided by the MOA Parks Department, the porous asphalt was not designed for heavy truck loading. The heaviest expected vehicle to utilize the parking lot was the truck that services the onsite porta potty.

Light surface raveling of the asphalt was noted in last year's monitoring report, and was observed to be continuing, though not significantly worsened from last year. As discussed in the 2015 report, the absence of frequent sweeping of the parking lot is expected to compound this issue because the unraveled rocks remain on the surface and are then ground into the remaining asphalt under vehicular traffic. Photos from the July 17 site visit are shown in Figure 4.

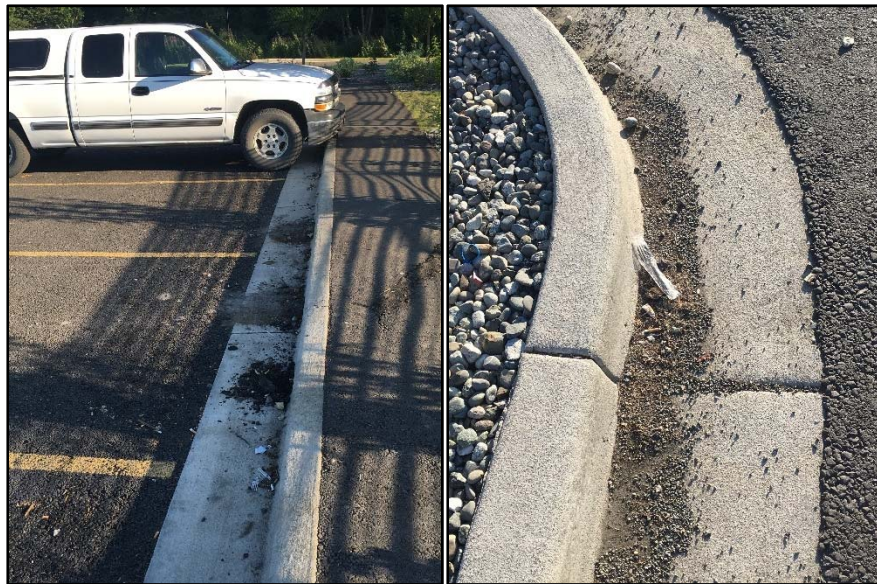
Sand in the Porous Asphalt Pores

Dirt and Debris on the Porous Asphalt and in the Gutters

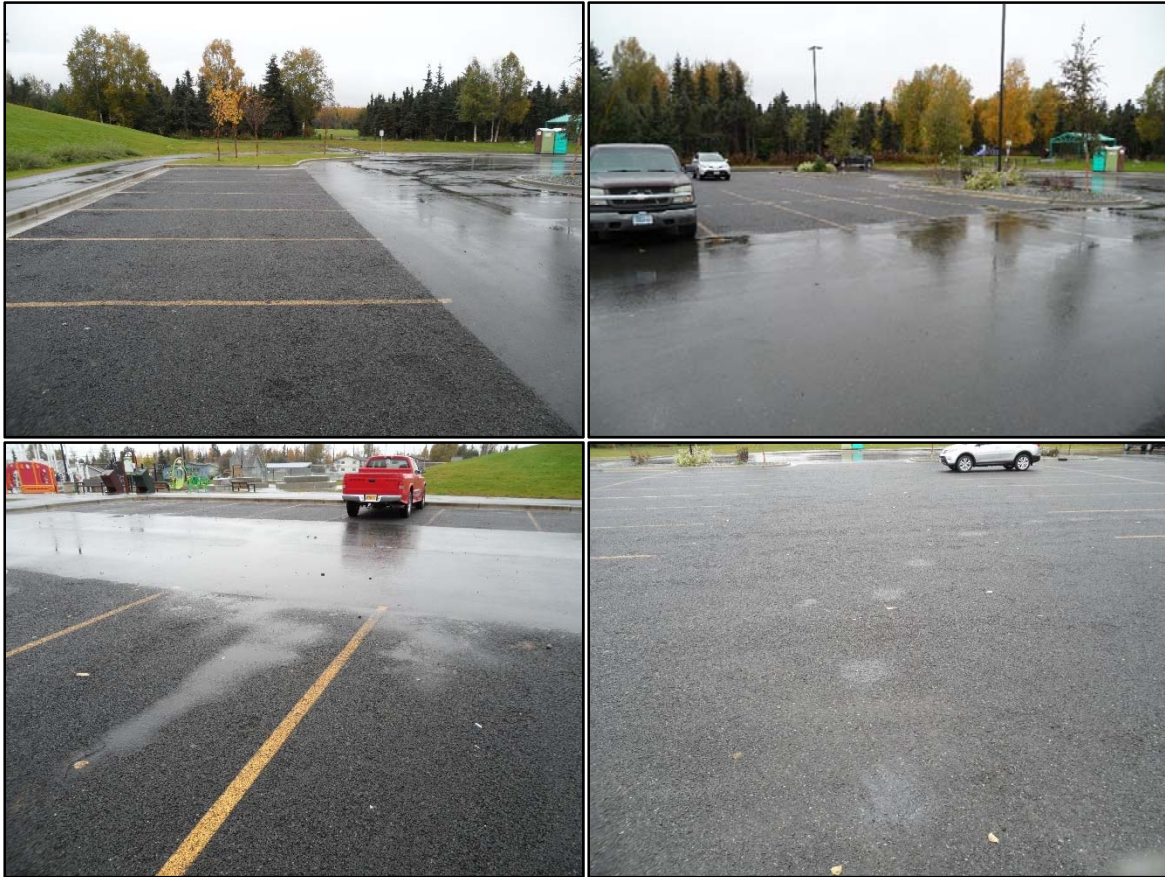
Figure 5: RJSP Parking Lot September 22, 2016

During the September 22 site visit, it was raining and the parking lot observed to be well-drained, despite the above-listed concerns. Some light ponding on the porous asphalt areas was observed, indicating that water is either not flowing freely through the asphalt pores, or the asphalt infiltration rate is slower than the rate of incoming runoff. These areas were few and were typically limited to locations near seams where the asphalt transitions to traditional non-porous asphalt, or to areas that were previously noted to be clogged with organic debris. Areas near the seams receive runoff from the non-porous asphalt surface, resulting in more concentrated runoff.

The three monitoring wells in the porous asphalt were checked and water levels were observed to be very consistent with previous years' levels, indicating that the parking lot subgrade continues to drain well. The subdrain was not flowing.

The subsurface infiltration system was inspected via the chamber inspection ports, and standing water was not observed. This system is out-performing design expectations even with the addition of incoming flows from the east, which was not included in the design. Photos of the site from the September 22 site visit are presented in Figure 5.

The MOA Parks Department indicated that this parking is swept regularly and that they have made efforts to keep organic materials such as mulch and dirt off of the porous asphalt. They also noted that the surface raveling tends to worsen during warm summer days due to tires turning on the surface when the heat has loosened the asphalt binder. This is consistent with observations presented in previous years' monitoring reports. Parks noted they were happy to support LID demonstration project efforts, but that other LID techniques that utilize park green space may have provided a similar benefit with less maintenance.

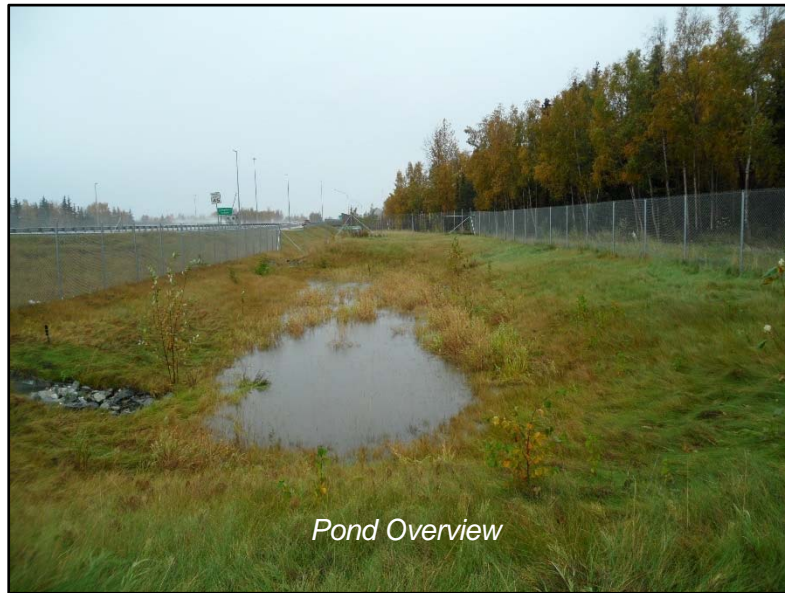
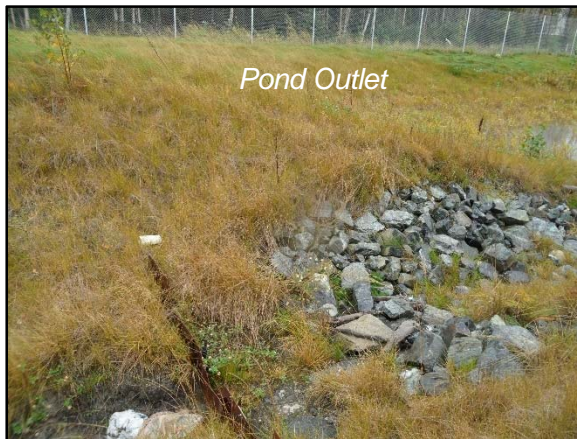
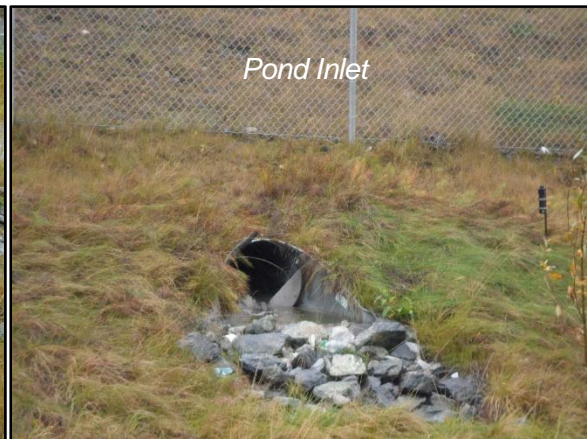
Figure 7: NSH Infiltration Basin September 22, 2016

2016 Observations. The September 22 observations indicate that this infiltration pond continues to perform very well. The inlet was flowing and standing water was observed in the pond, but the water surface elevations were well below the pond outlet elevation. Water is being captured, infiltrated, and treated for small and mid-size rain events, and the facility is exceeding its design capacity of 0.52 inches of rain. The inlet and outlet weirs that were placed during the 2013 monitoring program were still in place. Photos from the September 2016 site visit is provided in Figure 7 below.

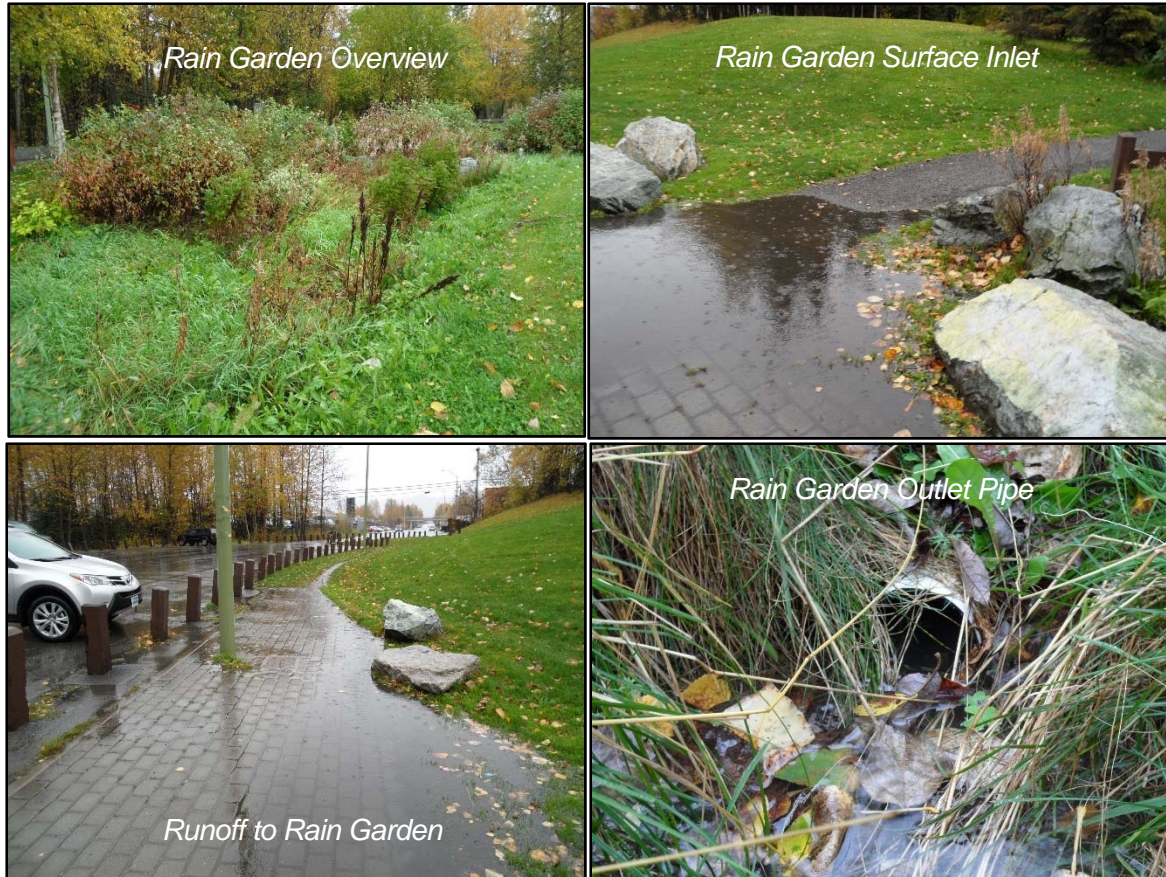
Figure 9: Taku Lake Rain Garden September 22, 2016

2016 Observations. The September 22 observations continue to show that the rain garden is performing well. Water was observed to be flowing into the rain garden from the upstream impervious areas and a small amount of ponding was observed near the surface flow inlet. There was no standing water observed in the rain garden. The outlet pipe was flowing slowly, with water pooling downstream of the outlet and slowing the outlet flow velocities. The observations indicate that the rain garden is still providing successful retention of small rain events, and detention and water quality treatment for larger rain events. Vegetation in the rain garden is well established, and native vegetation is present in addition to planted species. Photos from the September 22 site visit are provided in Figure 9.

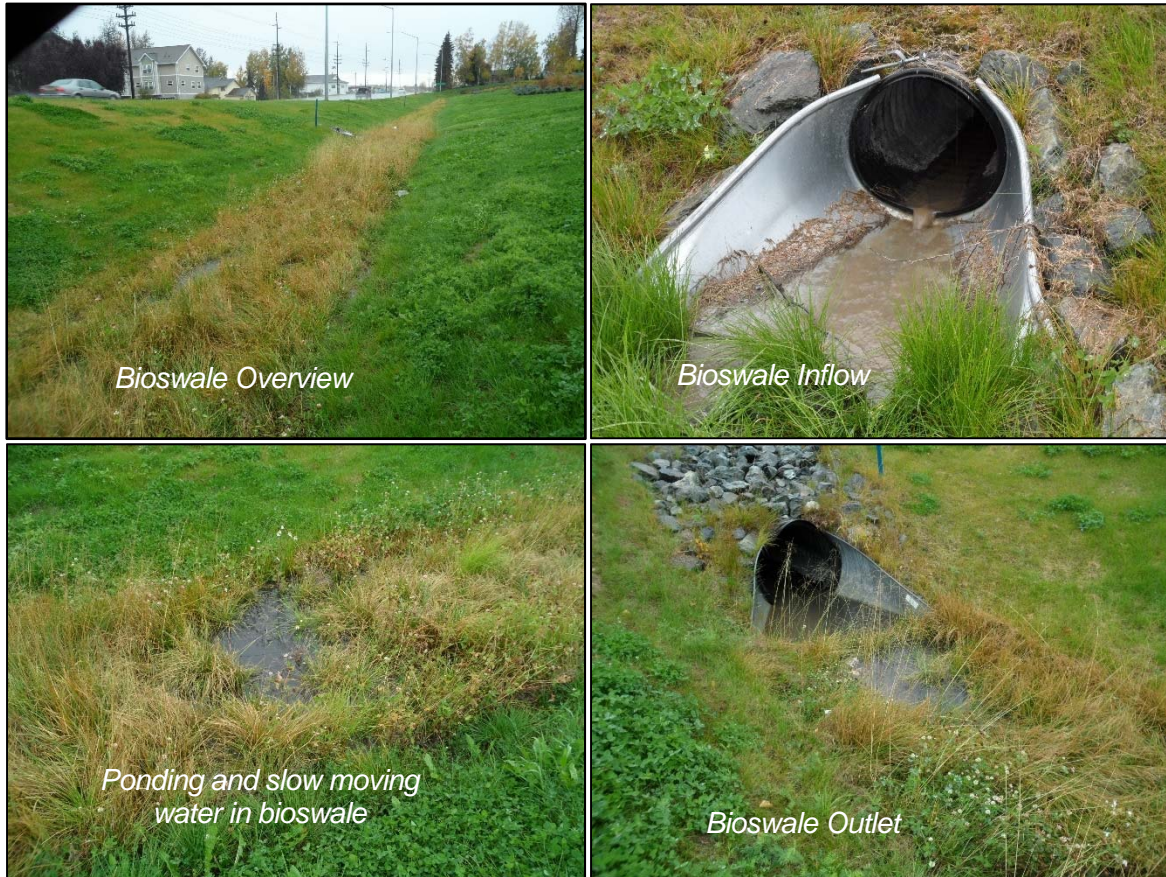
Figure 11: West Dowling Bioswale September 22, 2016

2016 Observations. The September 22 observations show that this swale is still performing well. During the site visit, water was entering the swale from most of the incoming storm drain pipes and trickling slowly toward the facility outlet. Previous years' monitoring reports have noted that vegetation in the swale was mowed fairly short, and it was noted that performance of the swale would likely be enhanced by letting the vegetation become more established. This year, the vegetation along the swale bottom was not mowed. The longer branches of grass provided additional slowing of the flow through the swale, and it is expected that improved treatment and peak flow attenuation were achieved. Photos from the September 22 site visit are provided in Figure 11.

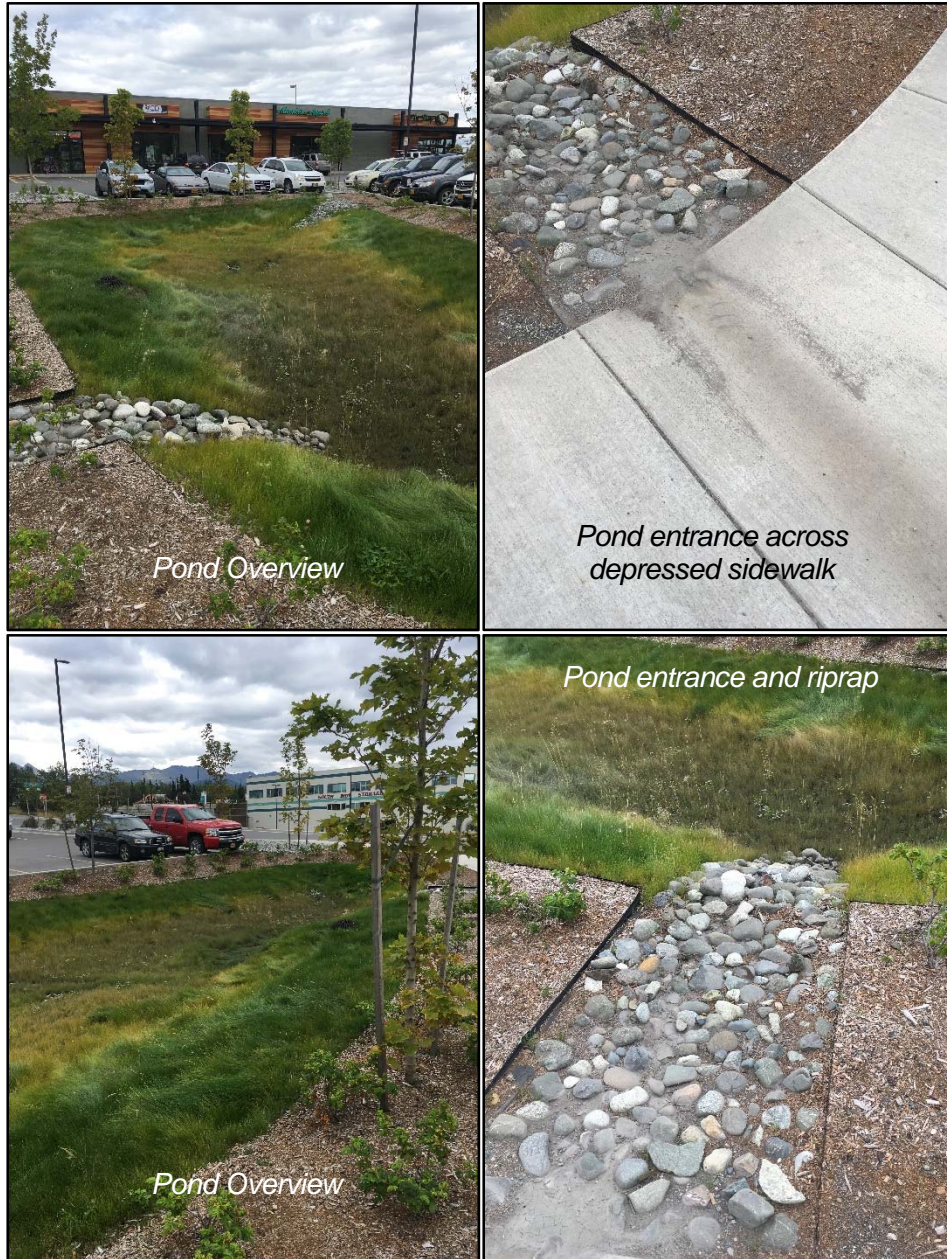
Figure 12: South Restaurant Pond July 30, 2016

This site was visited on July 30 during dry conditions, and again on September 22 during the rainfall event discussed previously. During dry conditions, the pond was observed to be approximately five or six feet deep, with gently sloping sides. The pond is vegetated with unmowed grass and the perimeter is landscaped with shrubs and mulch. Riprap is placed at the pond entrances for erosion control. There is a beehive style outlet located near the top elevation of the pond. It is expected that the beehive provides overflow for events higher than the design event of the pond, but the design information was not available to confirm this intent. The downstream outlet of the pond is not known. Photos of the pond from the July 30 site visit are provided in Figure 12.

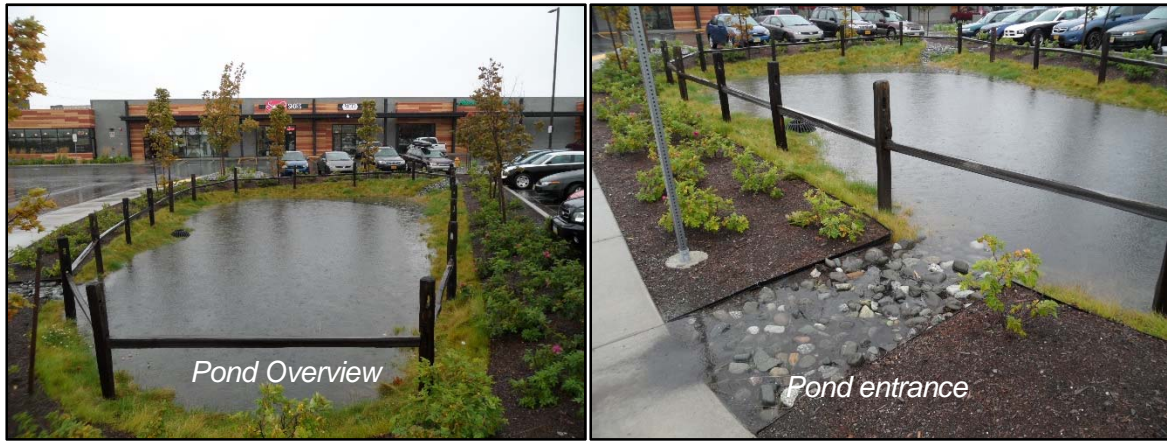
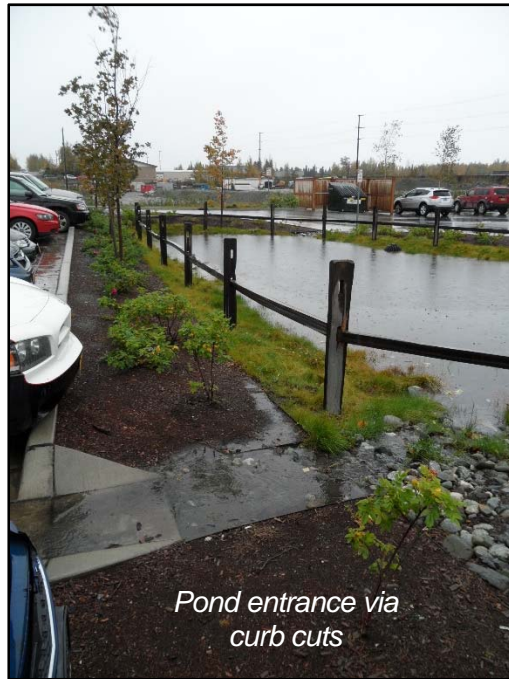
Figure 13: South Restaurant Pond September 22, 2016

During the September 22 site visit, the pond was observed to be full with the beehive flowing. Water was observed to be actively flowing into the pond from both of the pond inlets. Based on the recorded rainfall of 0.66 inches of rain on September 22, this pond may be intended to provide storage/infiltration of events up to the water quality event of 0.52 inches of rain, with larger events overflowing to separate system via the beehive outlet. (The water level of the pond at the start of this rain event is not known.)

Performance of the pond relative to the intended design performance is not known. The MOA plans to incorporate this site into future monitoring programs to gain additional information. However, the site provides an excellent example of integrating Green Infrastructure into a commercial development. The facility is both aesthetic and functional.

Features such as depressed curbs and sidewalks provide dual functionality as both site features and stormwater management assets. Photos of the site from the September 22 site visit are provided in Figure 13.
