SUBJECT: APDES Inspection of ANC Taxilanes E1, E3 and E&G Reconstruction,
Authorization Number AKR10GP78, AKR10GP79

APDES INSPECTION REPORT

Name of Facility: ANC Taxilanes E1, E3 and E&G Reconstruction

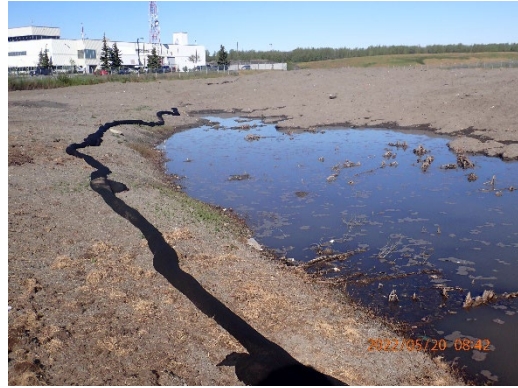
Photo 62

Comp Sock in Employee Parking

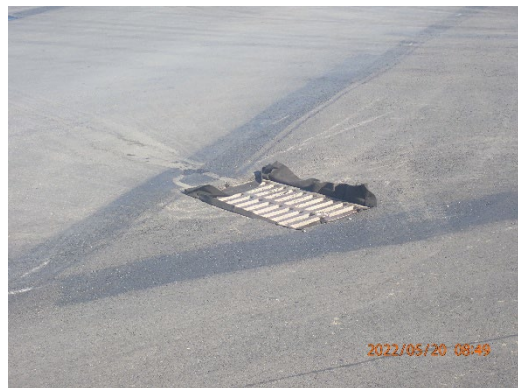
Photo 66

Witches Hat in Storm Water Grate

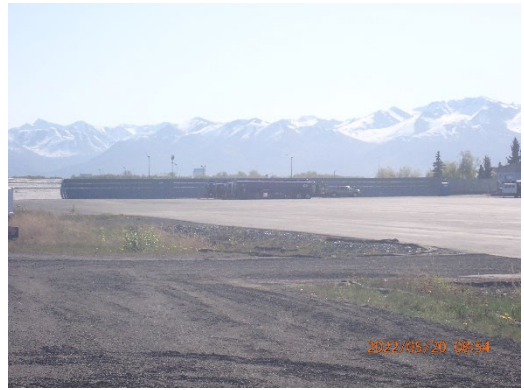
Photo 74

Composite Sock Around Ditch Line

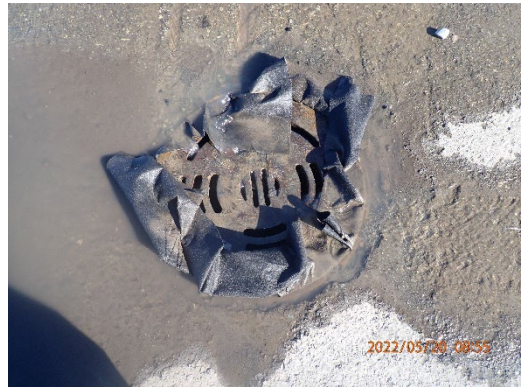
Photo 76

Witches Hat in Storm Water Grate

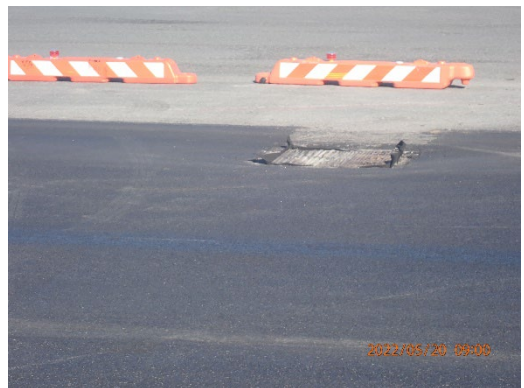
Photo 78

Witches Hat in Storm Water Grate

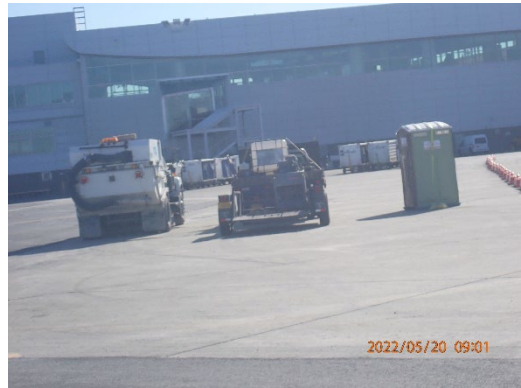
Photo 80

Port-A-Potty Strapped Down

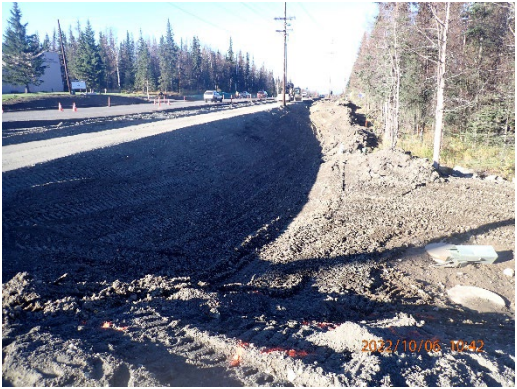
Incorrect Track Walking, Vertical Not Horizontal	Unsecured Port-A-Potty

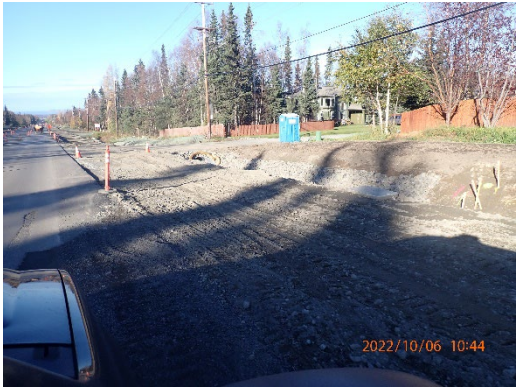
- It was noted during the inspection that a port-a-potty had not been strapped down to prevent tipping. It was remedied after the inspection, and a photo was submitted to show the correction.
- It was noted that a section of dirt work along the bank of a stream looked as if it could potentially partially erode under heavy rains and send sedimentation down the stream. However, no sedimentation or sediment transport was observed during the inspection. The section was stabilized to prevent potential issues.
