SUBJECT: APDES Inspection of HISP Highway Rockfall Mitigation, Authorization Numbers AKR10GI41 and AKR10GI51.

# APDES INSPECTION REPORT

Name of Facility: HSIP Highway Rockfall Mitigation

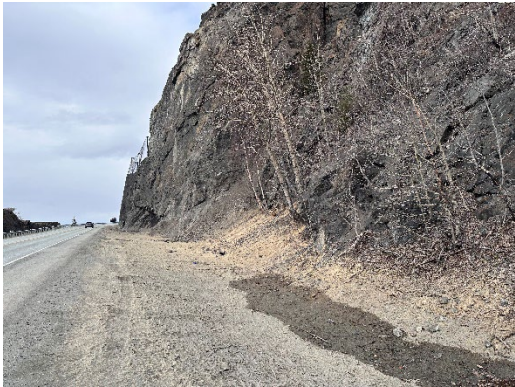
<p style="text-align: center;"><b>Photo 03</b></p>

<p style="text-align: center;">Stabilization</p>	<p style="text-align: center;">Snowmelt to existing culvert and vegetation</p>

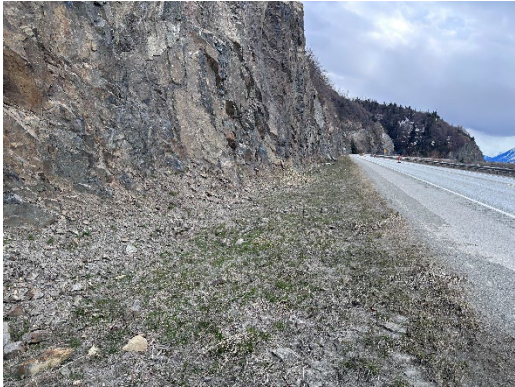
<p style="text-align: center;"><b>Photo 05</b></p>

<p style="text-align: center;">Vegetative buffer</p>	<p style="text-align: center;">Straw wattle</p>

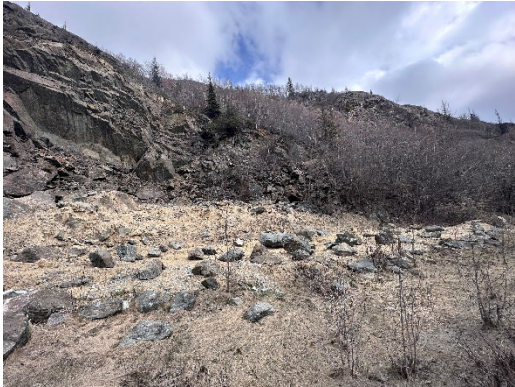
<p style="text-align: center;"><b>Photo 07</b></p>

<p style="text-align: center;">Stabilization</p>	<p style="text-align: center;">Vegetative buffer</p>

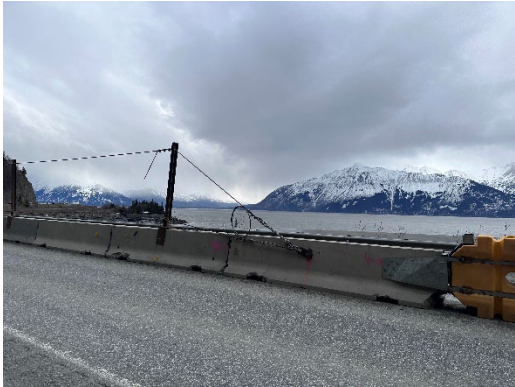
<p style="text-align: center;"><b>Photo 11</b></p>

<p style="text-align: center;">Highway divider and crash barrier</p>	<p style="text-align: center;">Spill kit in project zone</p>

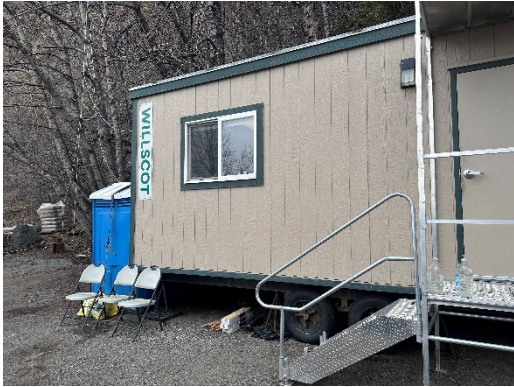
**Photo 13**

Staff trailer in staging area

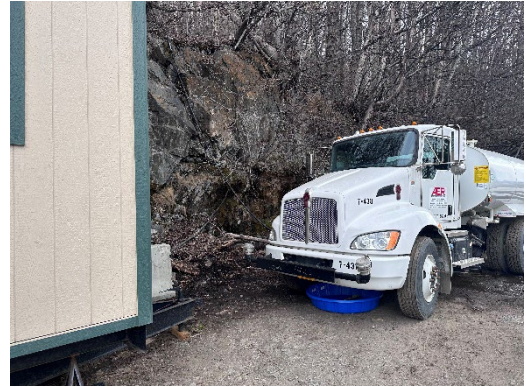
**Photo 14**

Water truck with duck pond

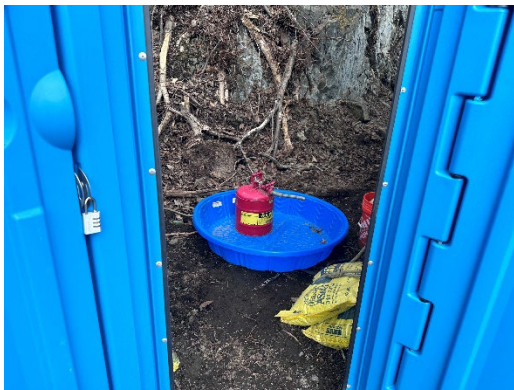
**Photo 15**

Secondary containment fuel storage

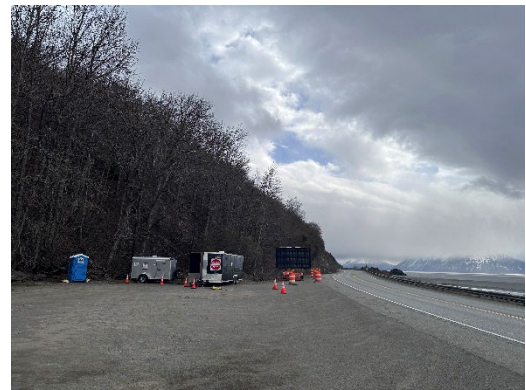
**Photo 16**

Flagging contractor staging area and sign

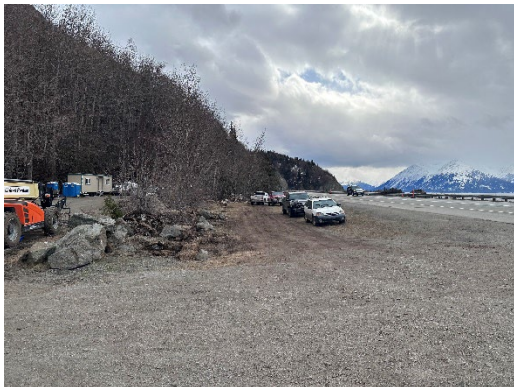
**Photo 17**

Staging area equipment and vehicles

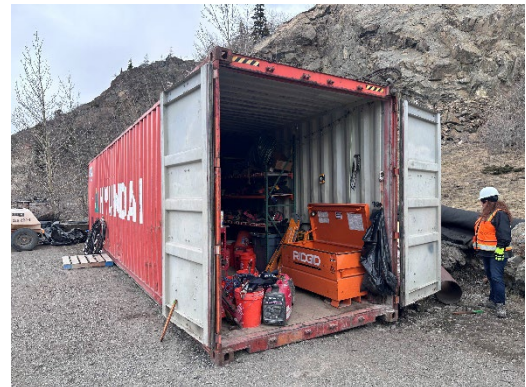
**Photo 18**

Connex covered storage

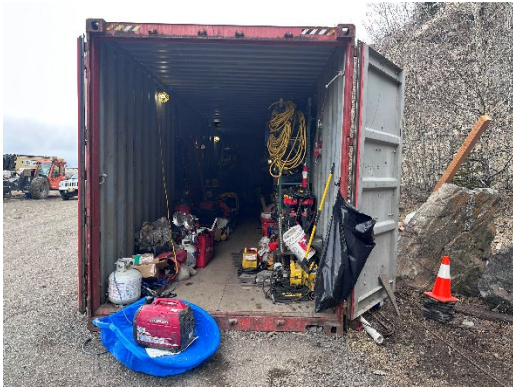
**Photo 19**

Secondary containment

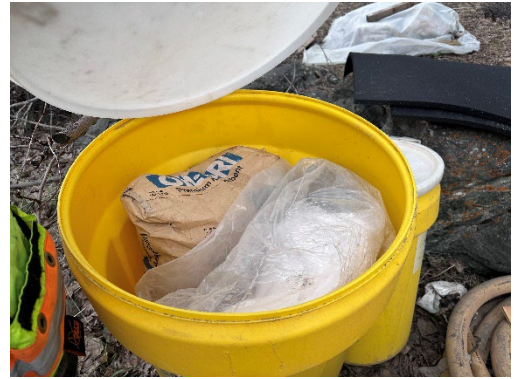
**Photo 20**

Spill kit contents

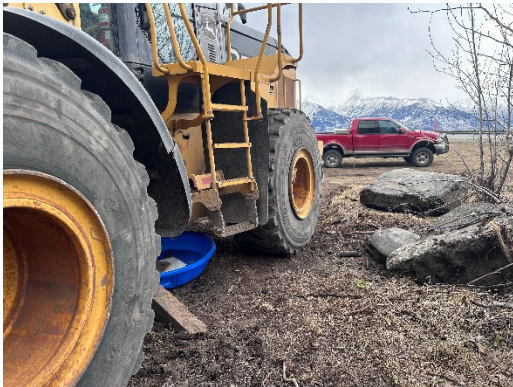
**Photo 21**

Equipment duck pond

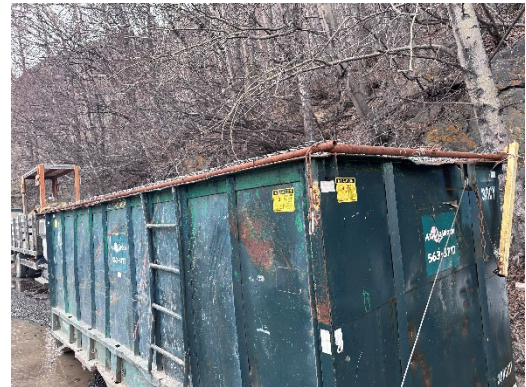
**Photo 22**

Covered dumpster

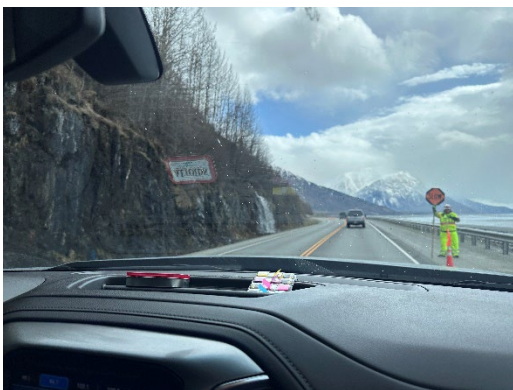
**Photo 23**

Flagger

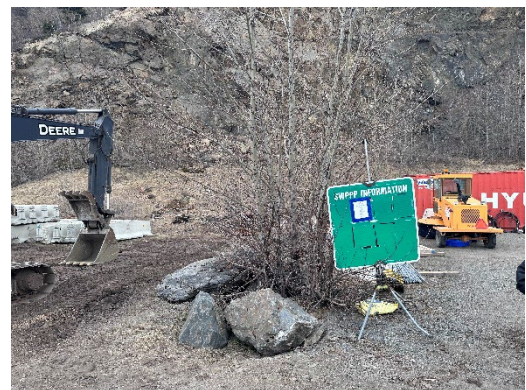
**Photo 24**

SWPPP sign

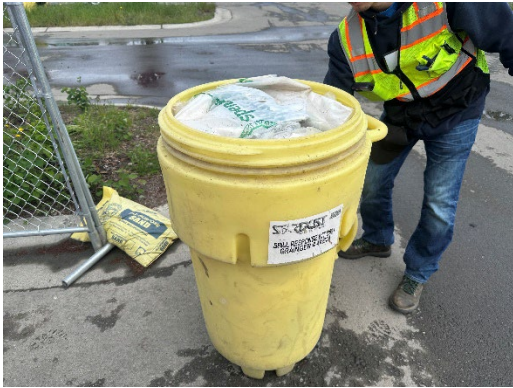
**Photo 07**

Spill kit contents in staging area

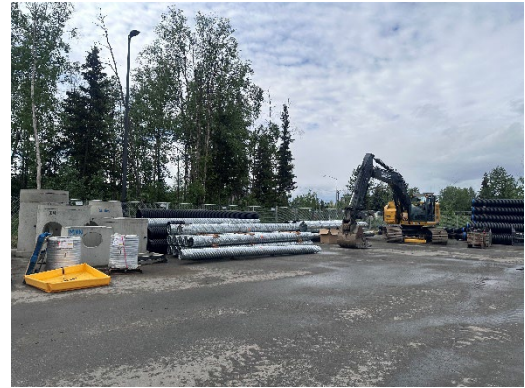
**Photo 08**

Material and equipment storage

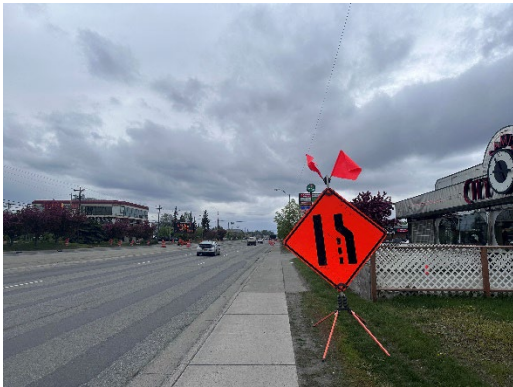
**Photo 09**

Minnesota Drive looking south

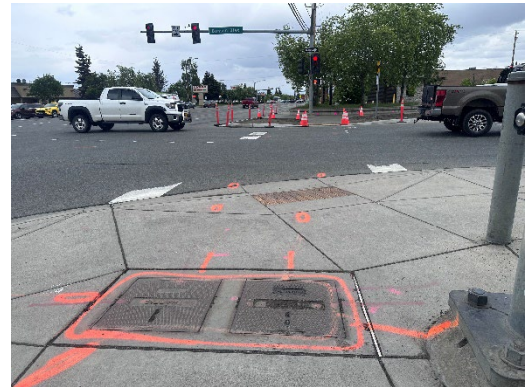
**Photo 10**

Minnesota Drive and Benson looking north

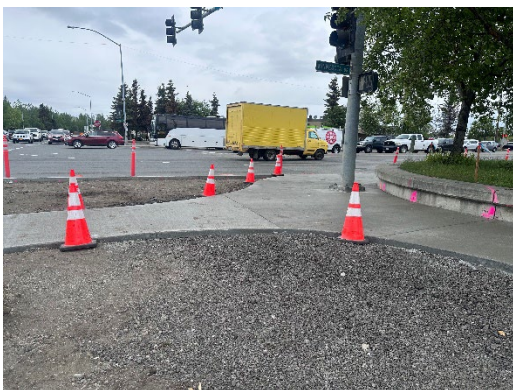
**Photo 11**

New concrete at Benson and Minnesota

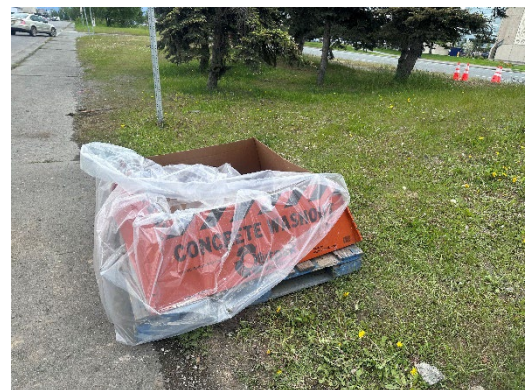
**Photo 12**

Lined concrete washout

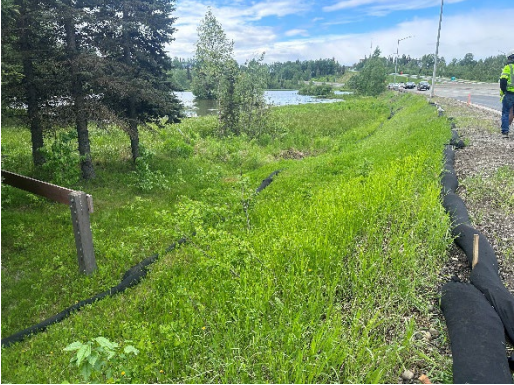
<p style="text-align: center;">BMPs along Westchester Lagoon</p>	<p style="text-align: center;">Bird nest (middle) by fiber roll BMP</p>

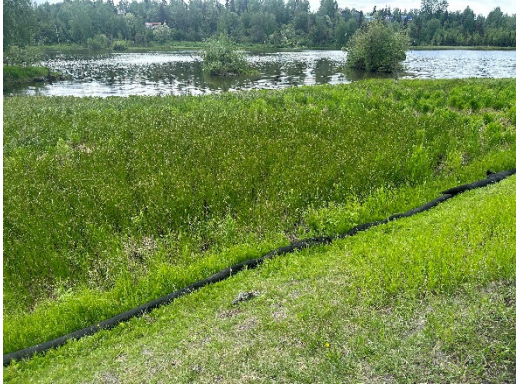
<p style="text-align: center;"><b>Photo 24</b></p>

- Storm water controls along West Chester Lagoon were adequately placed with limitations due to several active nesting locations, some nests were observed directly on the compost sock/fiber rolls and access was guarded by protective birds,
