MOA and DOT&PF 2023 Green Infrastructure and Low Impact Development Project Performance Monitoring Report

The Municipality of Anchorage

February 2024

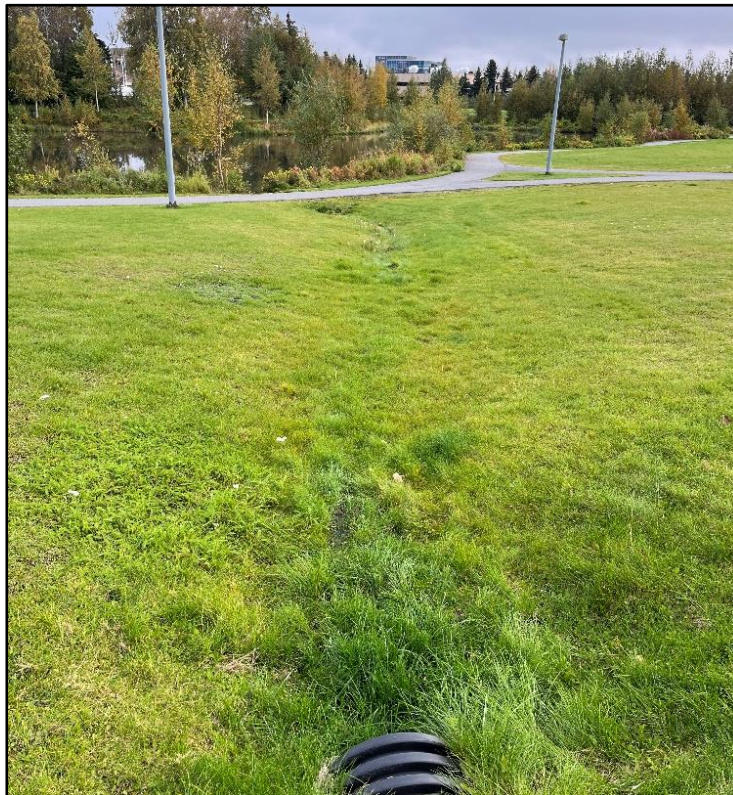
Existing drainage channel looking northeast toward Cuddy Park Pond

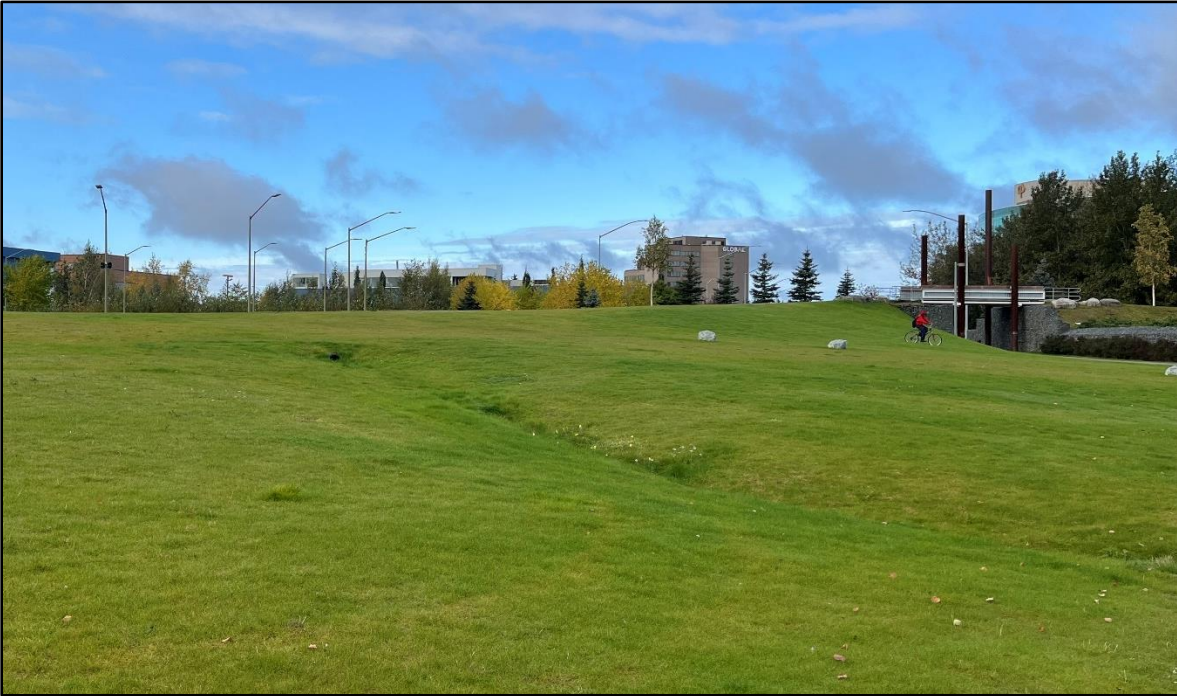
Existing drainage channel looking west toward 40th Avenue

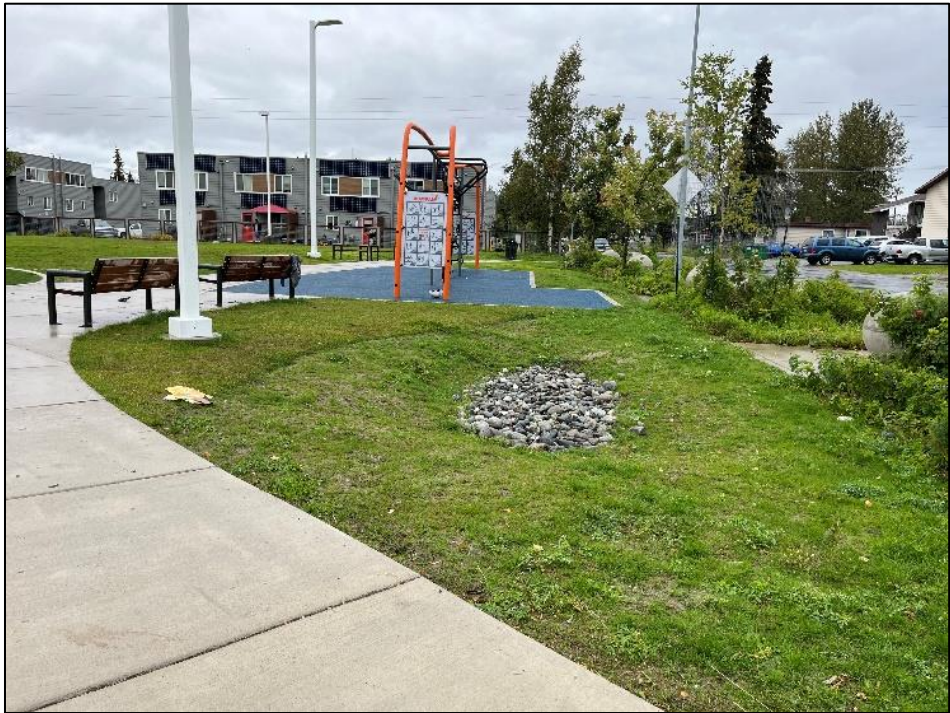
Northern landscaped depression, looking north.

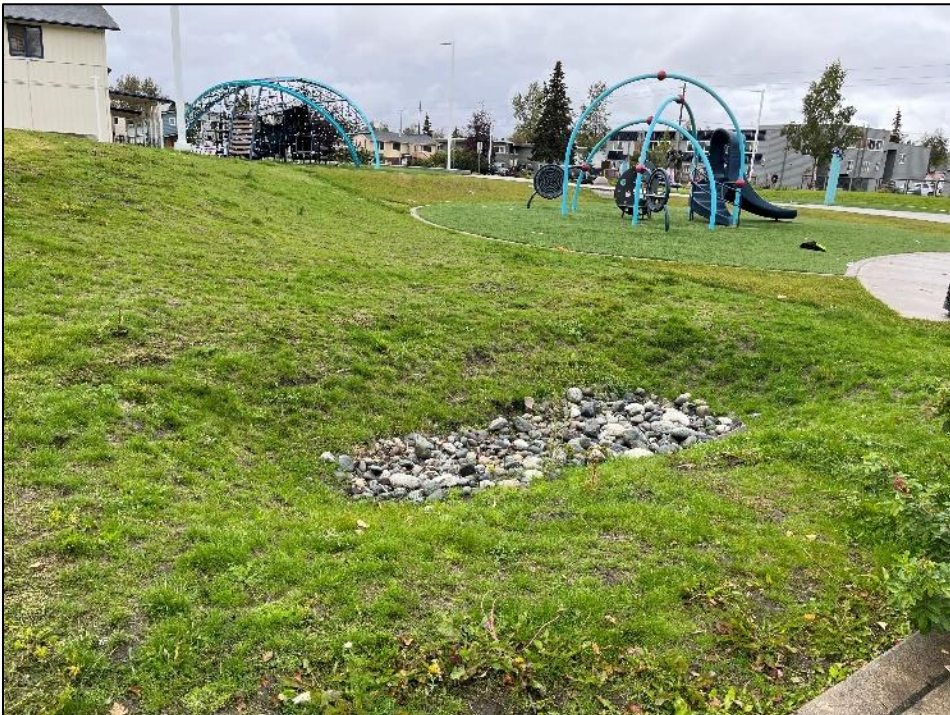
Southern landscaped depression, looking northeast.

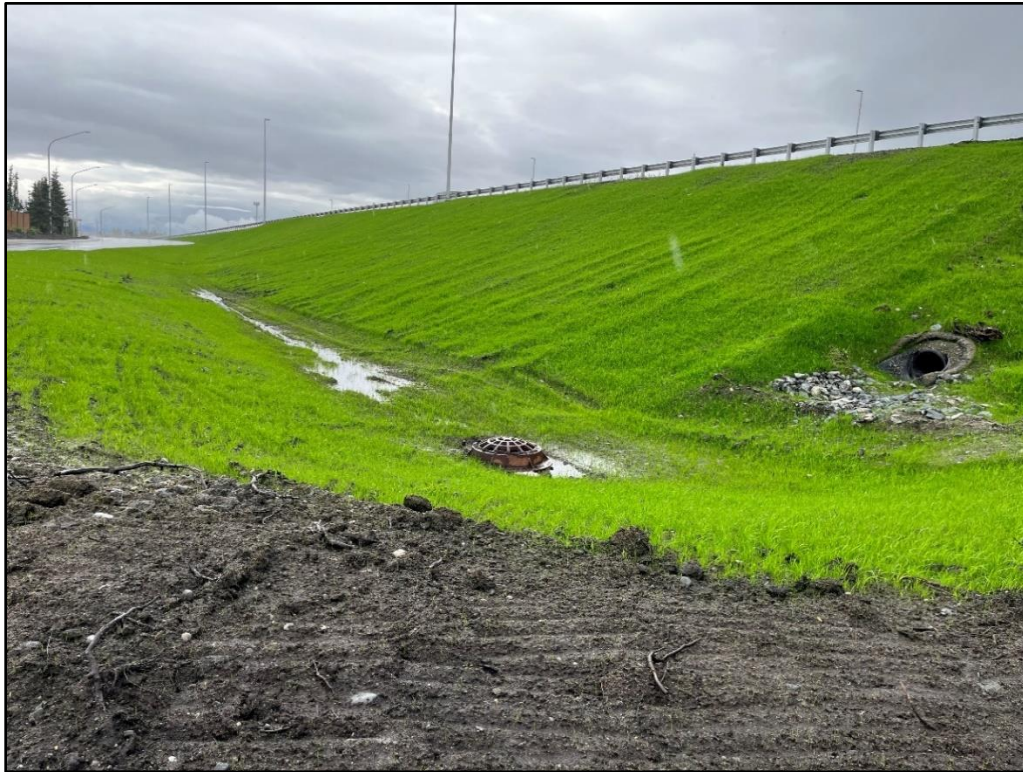
Pond D02. Photo taken from Dowling Road, looking south toward the Seward Hwy northbound off ramp.

During the September 21 site visit, water was observed to be ponding at the D02 infiltration area, but no water was flowing into the beehive outlet through the casting. A small amount of water was trickling into the outlet structure below the casting elevation, likely due to the concrete structure not being fully watertight. This indicates that pond D02 may be exceeding design expectations, as the September 20-21 event exceeded the water quality event by almost double.

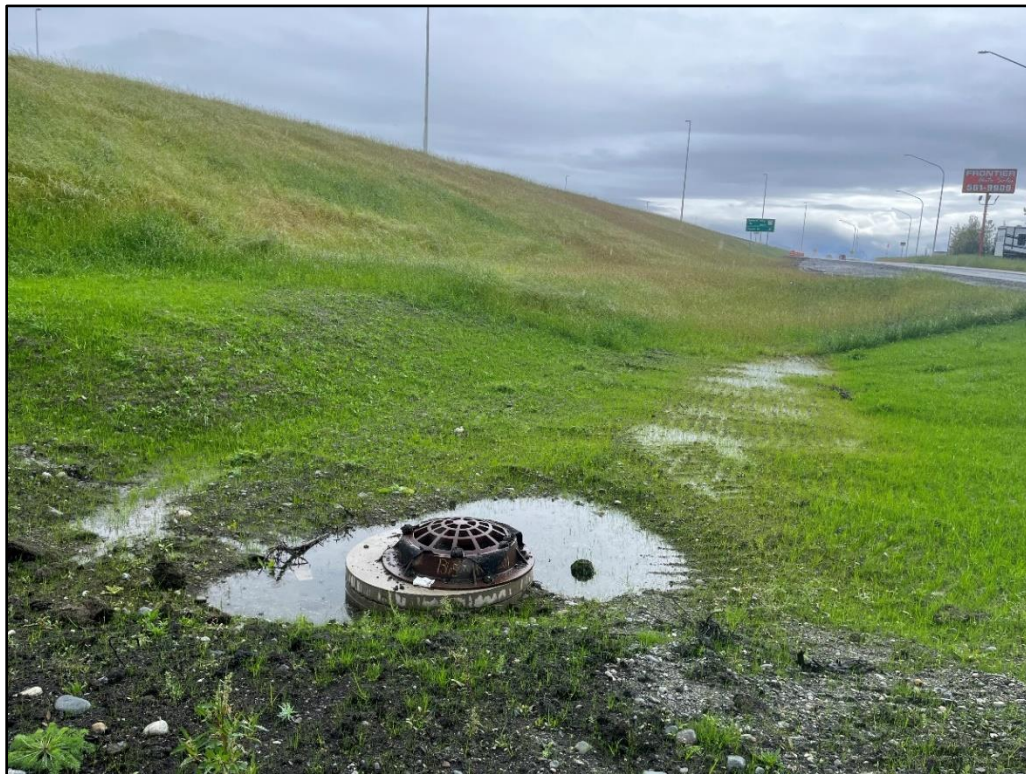
Pond D03. Photo taken from Dowling Road, looking south toward the Seward Hwy southbound on ramp.

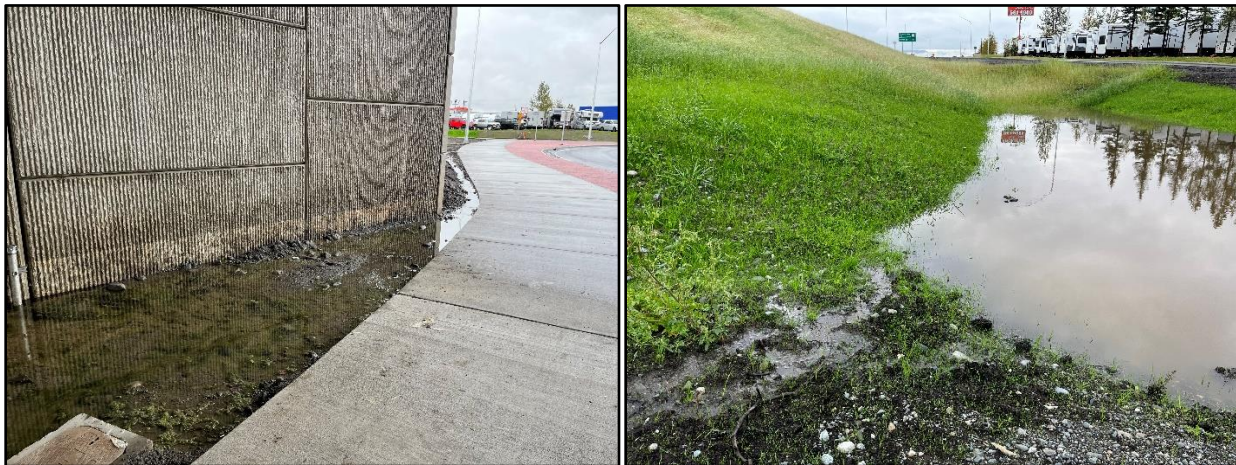
Figure 4: Groundwater Inflow to Pond D03

At Pond D03, water was ponding, and the beehive was actively flowing, allowing excess water to flow downstream. Pond D03 also appeared to have groundwater flowing in, originating from south abutment of the overpass bridge. This water was contributing to the observed flow into the beehive, as shown in Figure 4. However, even without groundwater inflow, overflow to the downstream system would be expected for this event, as it exceeded the water quality event by nearly double.

Left: Groundwater pooling at the southern bridge abutment and flowing to Pond D03.

Right: Water flowing into Pond D03 from the upstream groundwater.

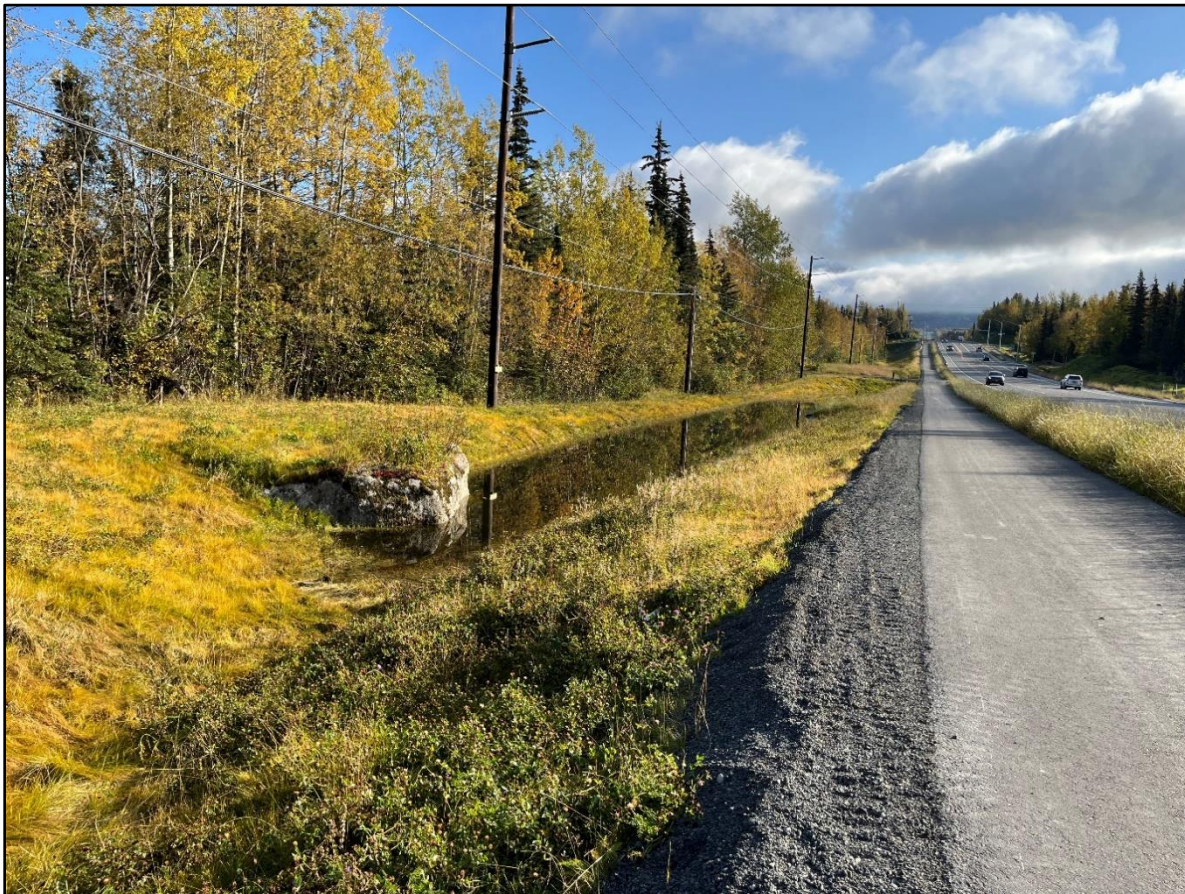
Figure 5: O'Malley Road Infiltration Basin

O'Malley Infiltration Basin, looking east toward Elmore Road

During the September 14 site visit, the basin was fairly full, but was not overtopping. The storm drain pipe entering the facility from the south was mostly submerged, and backwater was observed in the upstream storm drain catch basin on the south side of O'Malley Road. A small amount of water was overflowing at a low point in the berm on the north side of the basin. A follow-up visit was completed on September 15 to determine if the facility was draining. Water levels had receded, but the facility was still holding water.

During the September 21 site visit, the infiltration basin looked similar to the previous site visit. The basin was full with small amounts of water flowing out at the low point in the north berm. A follow-up visit was completed on September 25, as no measurable quantities of rain occurred September 22-25. The water surface elevation had dropped 0.25 feet from the previous site visit. Most of the inflow storm drain was still submerged, but water was not overflowing to the north.

Preliminary visual monitoring indicates that this project's infiltration basin may not be performing as designed. Because the September 14 event was not preceded by 48-hours of no precipitation, the site observations for this event are not fully reflective of the facility performance during the water quality event. However, the notable volume of water in the pond following four days of no precipitation indicates that the facility is likely not draining within the intended time frames. While the facility appears to have sufficient volume to store the water quality event, it may not be able to drain down within sufficient time to allow for storage of subsequent events.

Localized groundwater data at this location were not available for inspection. However, groundwater levels across Anchorage were high at the time of monitoring. If there is relatively shallow groundwater at this location, elevated groundwater levels could be impacting the facility performance. If this is the case, performance may improve during years when groundwater levels recede.

It is also possible that in-situ infiltration rates after construction of the basin were lower than the field percolation rates. This could be due to a variety of possible factors such as the facility floor being at a different elevation than the percolation tests, sediment inflow to the facility during or after construction, high groundwater as discussed above, and/or accidental compaction of the infiltration bed during construction.

The DOT&PF is currently planning site modifications focused on improving the performance of this facility. Depending on the timing of that work, additional performance monitoring may continue in 2024 after modifications are complete, or DOT&PF may choose to focus future monitoring efforts on a different location.
