MOA and ADOT&PF 2013 Low Impact Development Project Performance Monitoring Report

The Municipality of Anchorage

January 2014

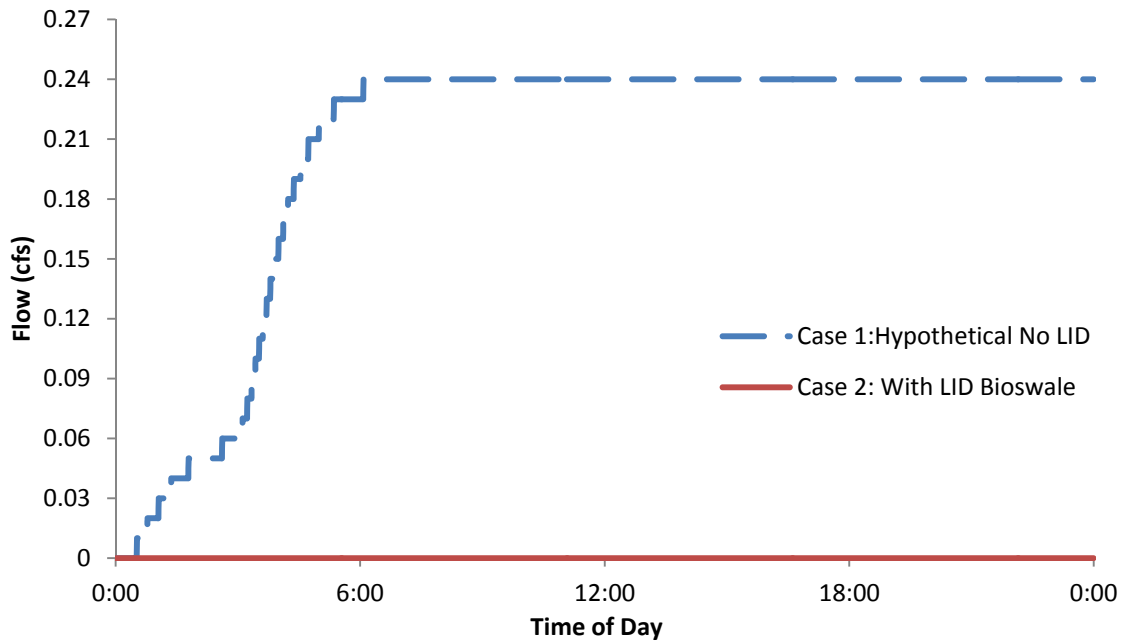
Figure 3: Event 1a - West Dowling Bioswale

For the evenly distributed 90th percentile event, the modeling results show that the swale was able to infiltrate all of the runoff and nothing was discharged to Campbell Creek. However, when the 90th percentile event was distributed as shown in Case 1b, not all of the runoff was infiltrated. The swale did reduce both the peak flow and the runoff volume for this case.

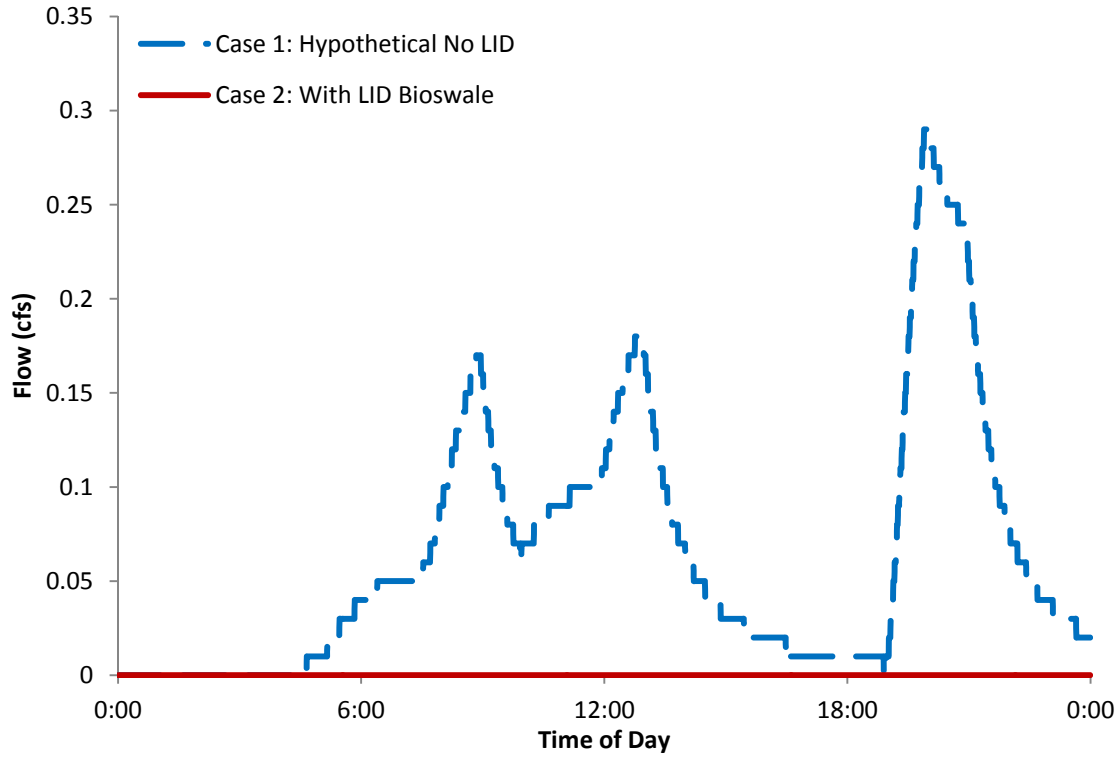
Figure 5: Event 2 - West Dowling Bioswale

For Event 2, modeling results show that the swale was able to infiltrate all of the runoff.

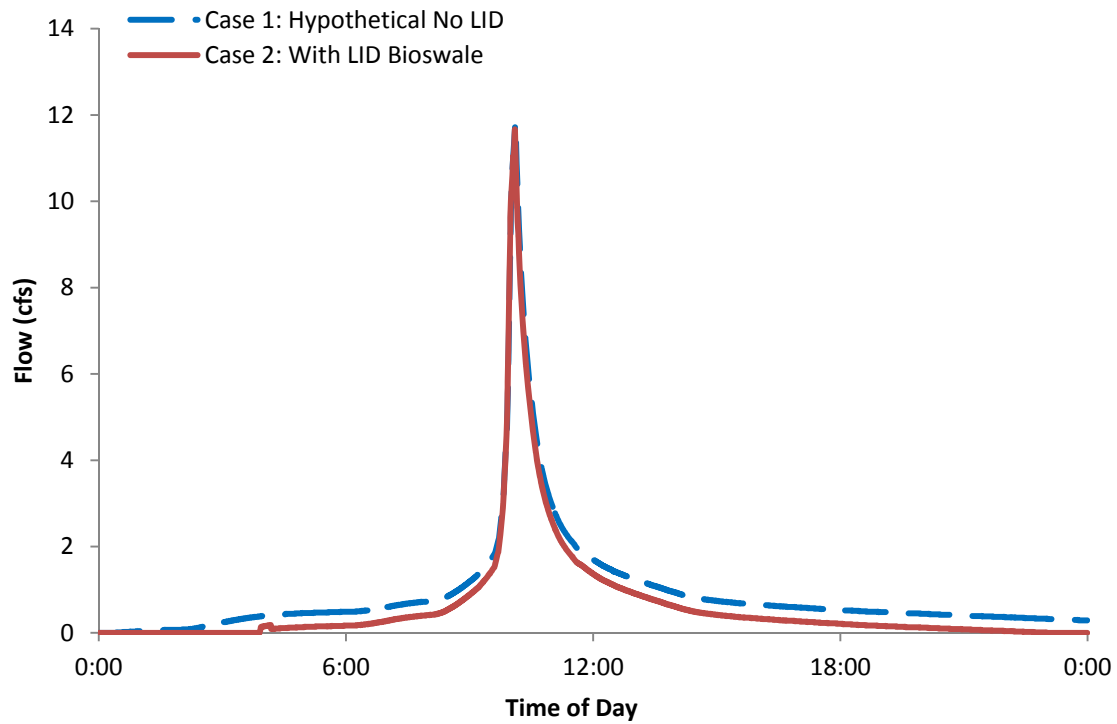
Figure 6: Event 3 - West Dowling Bioswale

For Event 3, the 10-year, 24-hour event, the modeling results show that although the swale did not have a significant impact on the peak runoff, it did result in a notable impact on the total runoff volume from the site. The modeling results show that a significant portion of the water entering the swale was infiltrated.

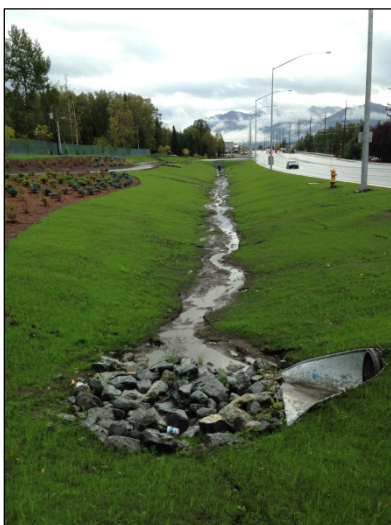
The swale performance was also visually inspected following several days of rain on September 7, 2013. Rain occurred each day for six days preceding the site visit. Rainfall records from AIA report a total of 1.67 inches from September 1 through September 7. The bioswale had small amounts of ponded water in the bottom at approximately three inches deep. Water was flowing in small quantities into the bioswale from its inlet points, and water inside the bioswale was flowing slowly toward the outlet. A small rock berm separated the swale from its outlet to Campbell Creek, and water was not flowing over this berm. No water was observed to be entering Campbell Creek.

*West Dowling Bioswale,
looking east*

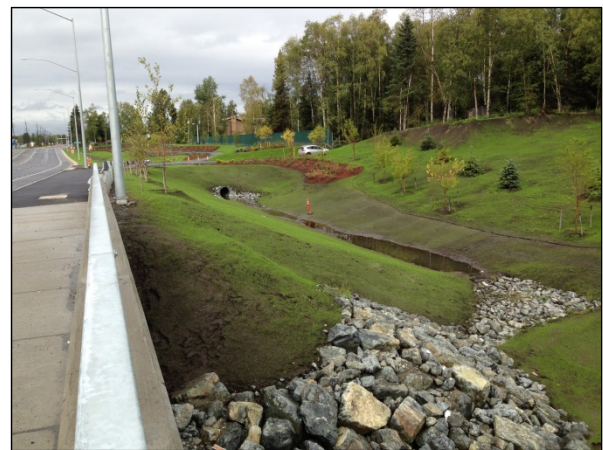
*West Dowling Bioswale, looking west from
Campbell Creek Bridge*

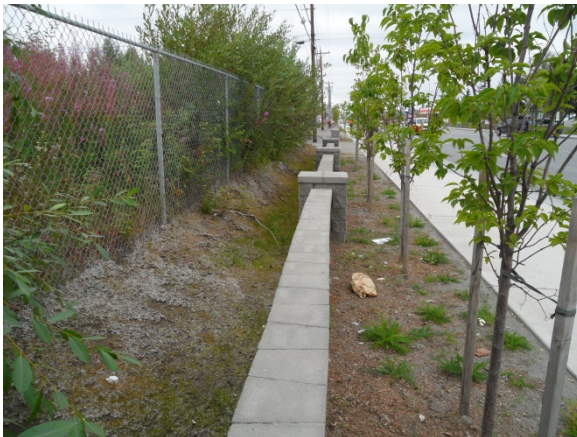
During the same site visit, it was also noted that in some cases, the decorative landscape walls were placed in locations that will inhibit the infiltrative performance of the landscaping. For example, in at least one location, a parking lot immediately adjacent to a landscape bed is sloped toward the landscaping, but the landscaping includes a decorative wall near the upstream edge, which limits the amount of stormwater runoff from the adjacent property that can enter the pervious area. In addition to reducing infiltration, this design is anticipated to be problematic for drainage and the stability of the landscape wall during spring breakup conditions.

Muldoon landscape area and decorative wall

3. Omit the landscape walls since they can actually impede drainage and add a small amount of impervious surface.
4. Require regular maintenance of the top soil and mulch to ensure that it does not clog due to winter sanding.

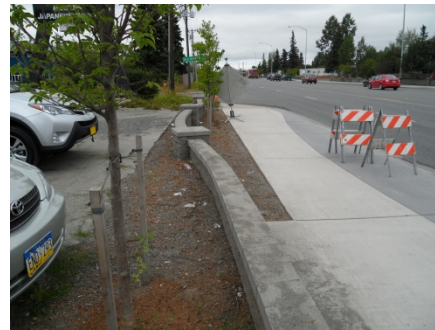
Muldoon landscape area and decorative wall

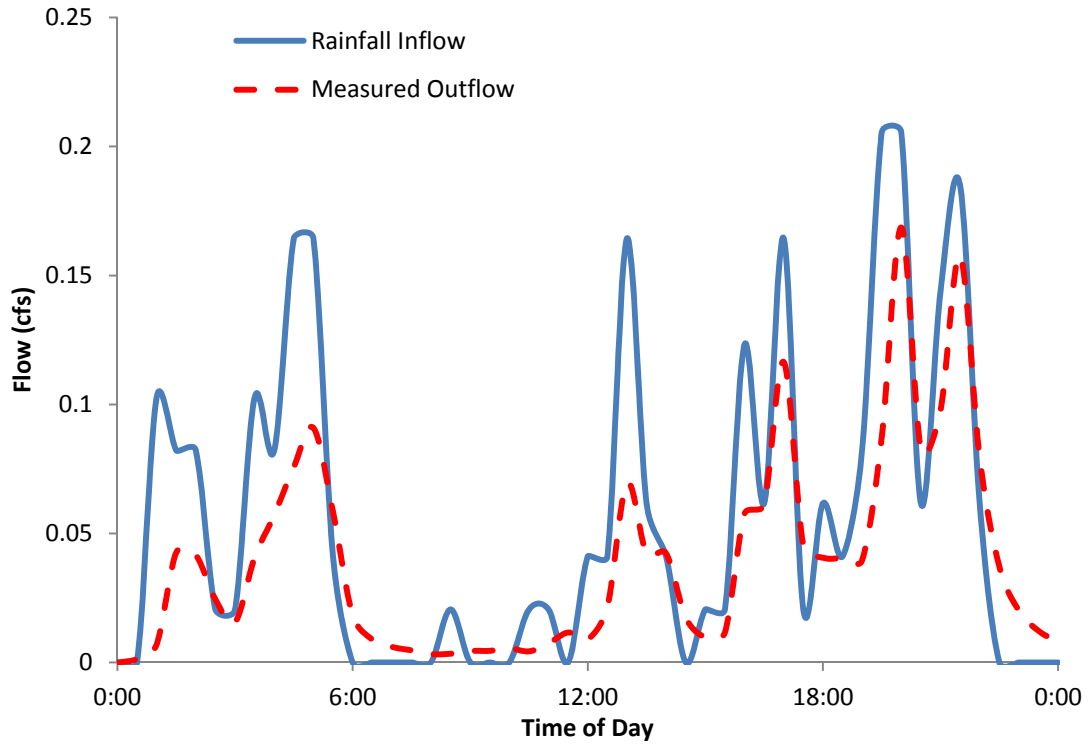
Figure 15: Event 1 Russian Jack Inflow and Outflow Hydrographs

As shown in the above hydrographs, the porous asphalt significantly reduced both the peak flow and the total volume of stormwater runoff from the parking lot in all three rainfall events evaluated. As noted above, this reduction would be even more significant if the additional contributing area east of the parking lot were accounted for.

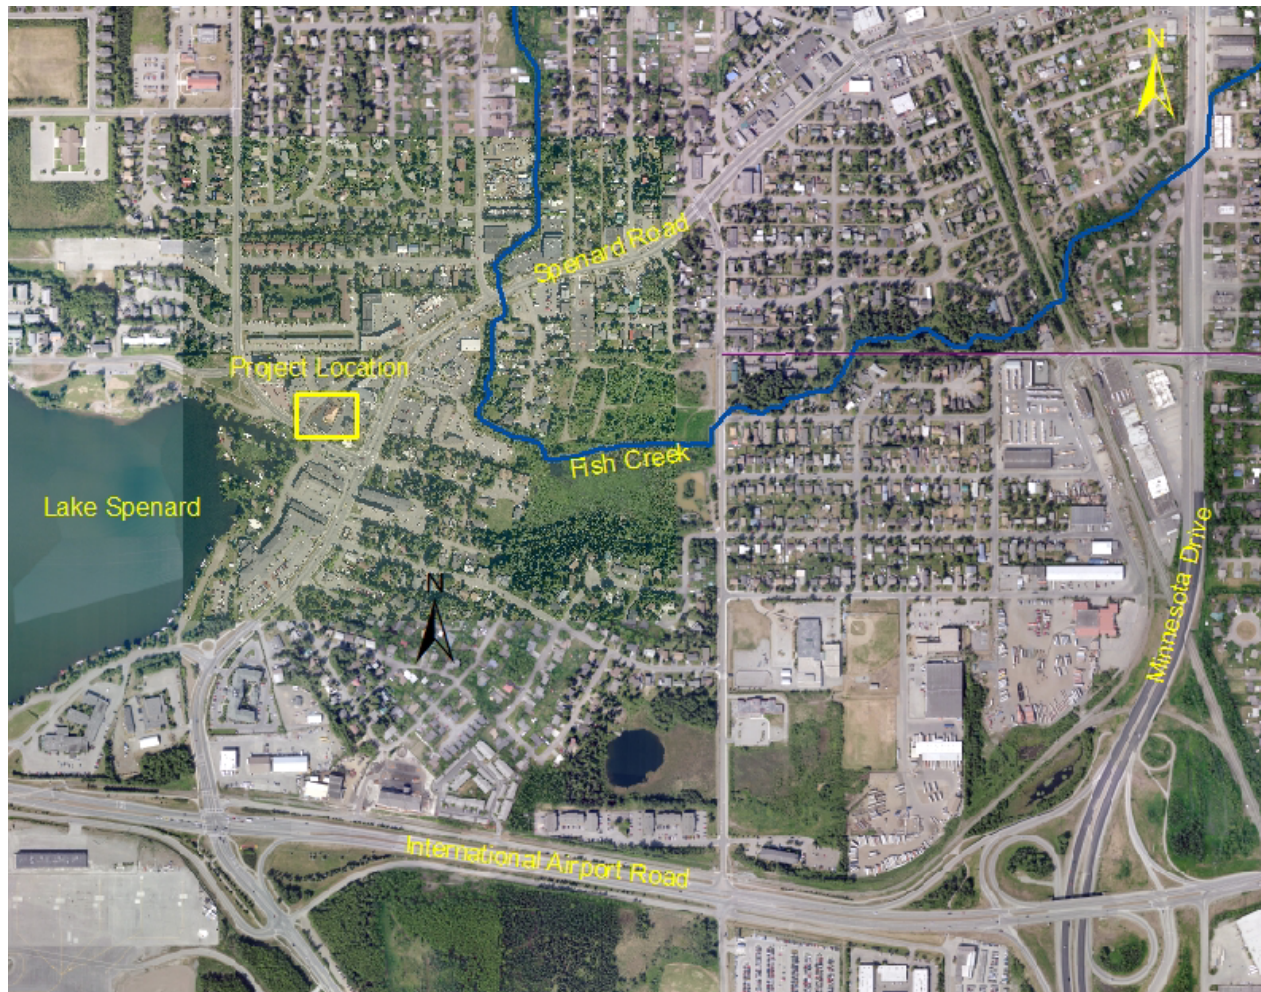
Figure 1: Project Vicinity Map

The CFAB rain garden was constructed in 2009 as part of an expansion and remodeling project for the CFAB building. WMS partnered with the CFAB owners and provided a portion of the rain garden funding through the MOA Rain Garden Program. The project is located at the corner of Lakeshore Drive and Wisconsin Avenue, near Spenard Road in Anchorage. The project site is in the Fish Creek watershed, which is cataloged as an impaired water body. Figure 1 provides a project vicinity map.

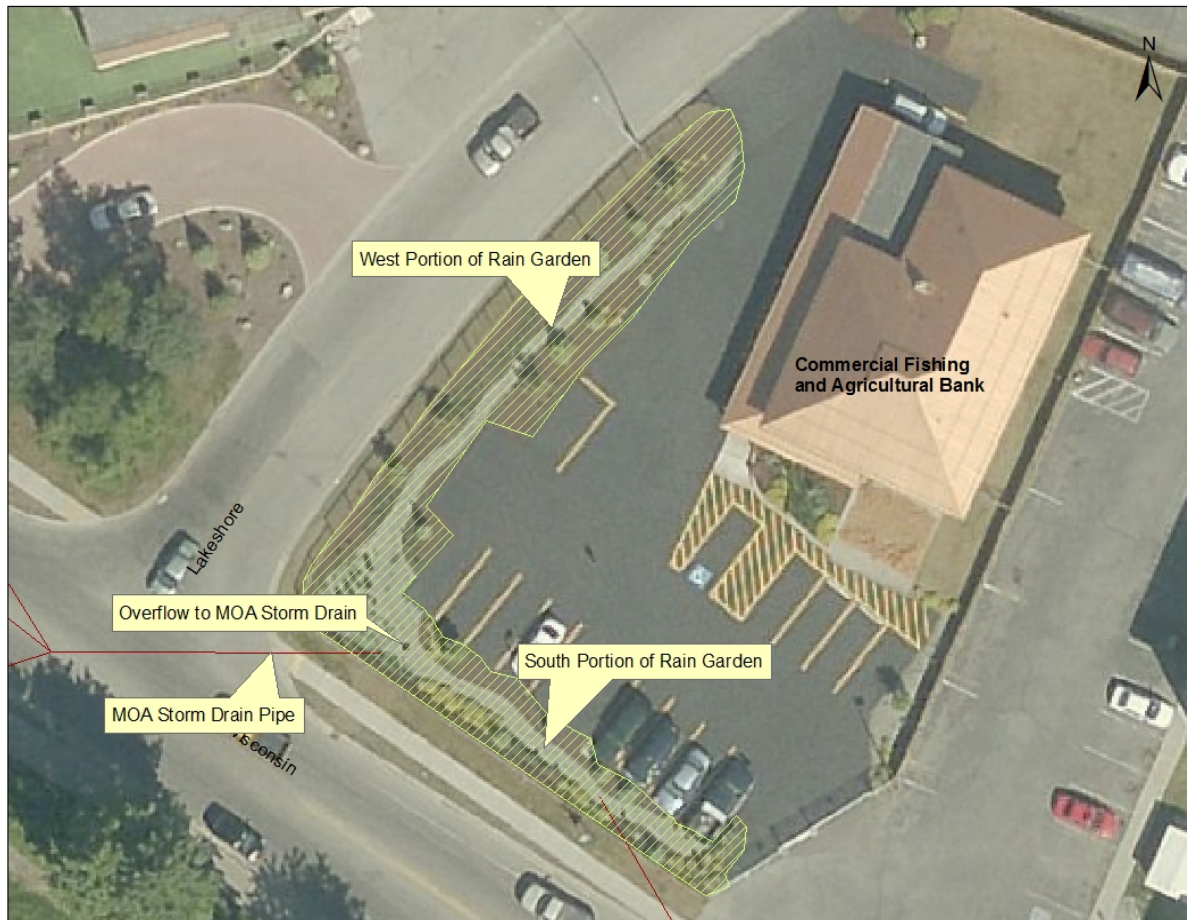
Figure 2: CFAB Project Site

There is an existing municipal storm drain adjacent to the CFAB site on Wisconsin Avenue that discharges to Fish Creek approximately 2,500 feet downstream from the project site. The rain garden is designed to capture stormwater runoff from the approximately 11,000 square-foot parking lot and from approximately 2,600 square feet of the building roof before this water can enter the municipal storm drain. The average slope of the contributing area is 1.8 percent.

The project site is shown Figure 2.

The rain garden was constructed along the south and west borders of the site, parallel to Wisconsin Avenue and Lakeshore Drive respectively. The western portion of the rain garden includes a central swale with a rock trench for additional stormwater storage capacity. The area around the swale/trench is organic topsoil with a mulch layer on top, and the area is vegetated with small shrubs and grasses. The southern portion of the rain garden features a depressed swale with a layer of rock on top of an organic topsoil layer to provide stormwater storage and encourage infiltration. The surrounding area is topsoil, mulch, and vegetation, similar to the western portion. Both rain garden sections slope toward the southwest corner of the site where a “beehive” storm drain inlet provides overflow for large storm events that exceed the storage and infiltration capacity of the rain garden. A typical section of the rock trench as well as construction photos of the rain garden are provided in Attachment 2.

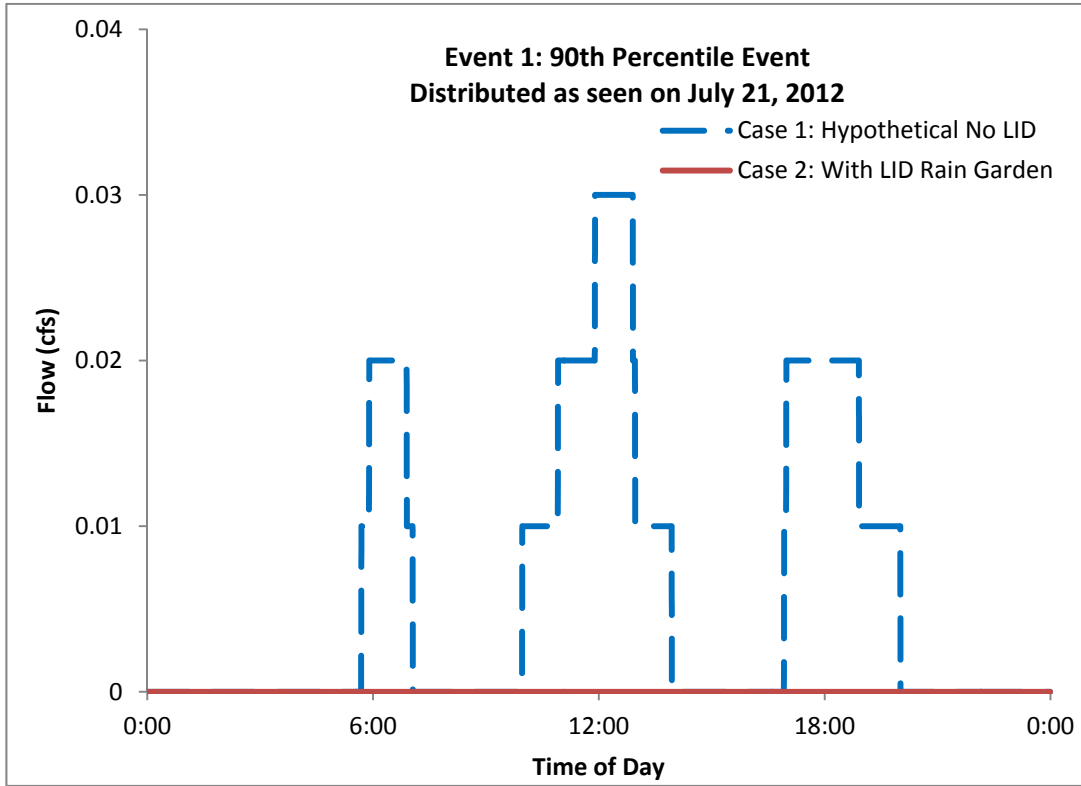
Figure 4: Event 1 Hydrograph

The resulting hydrographs are shown in Figure 4 and Figure 5. These hydrographs represent the discharge from the site into the local storm drain.

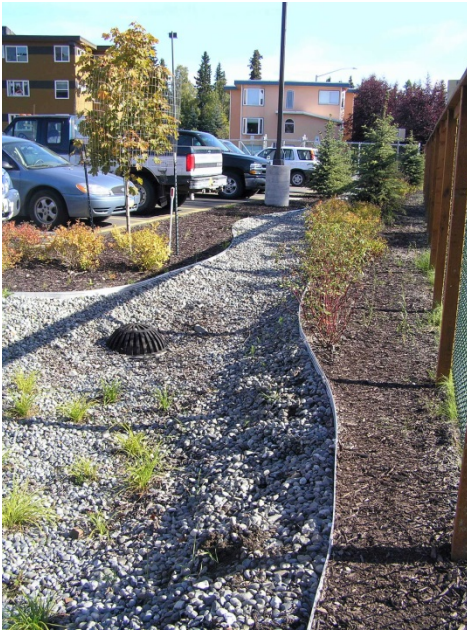
*Southern Portion of Rain Garden
(Wisconsin Ave. Side)*

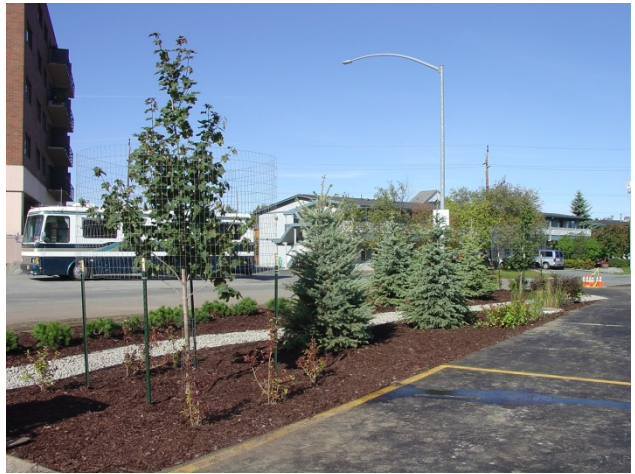
*Western Portion of Rain Garden
(Lakeshore Drive Side)*
