# **ANCHORAGE SNOW DISPOSAL SITES: 2013 EVALUATION**

Document No. WMP APr14002

Municipality of Anchorage  
Watershed Management Program

January 2014

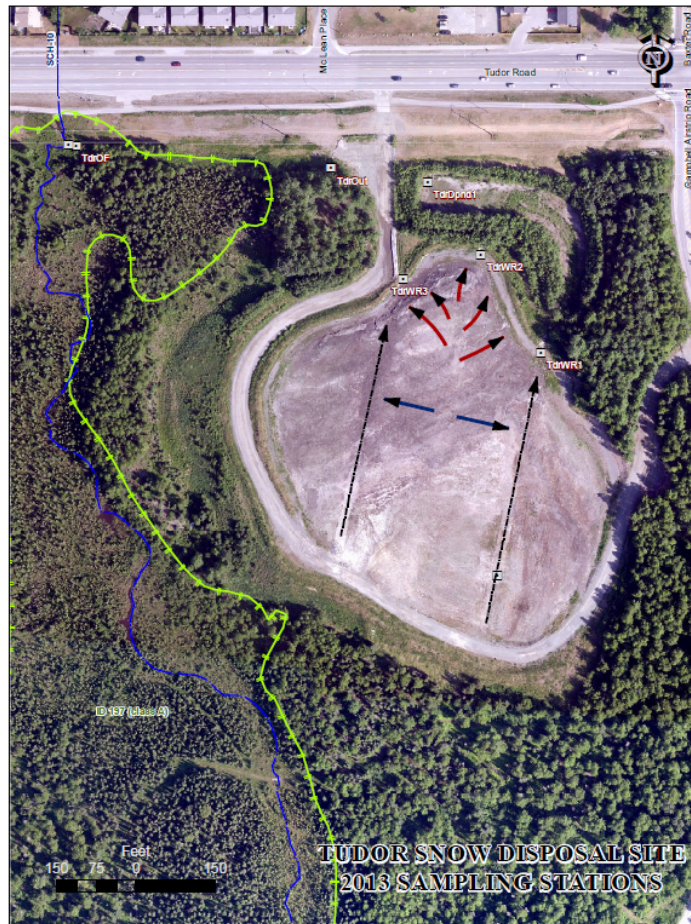
Figure 4: Tudor Snow Disposal Site 2013 sampling stations

For each of the sites, locations for field measurement and sample collection were established at critical process points relative to V-swale treatment. At Tudor, which includes a detention basin that is not sized to the site chloride loading, we selected the outlet weir at the base of one of the two primary V-swale elements as the primary sampling location (Tdr\_WR1). Additional sampling locations included a station at the outlet weir of the second major V-swale (TDR\_WR3), a station in the detention pond itself near its outlet (Tdr\_Dpnd1), a station at the ditched outfall of the site (Tdr\_OF), and a station in the receiving stream at a point just below the site outfall ditch (Tdr\_Stream). An additional sample was also collected of meltwater impounded upslope of the snowfill, i.e., of ‘backwater’ meltwater (Tdr\_Mpond).

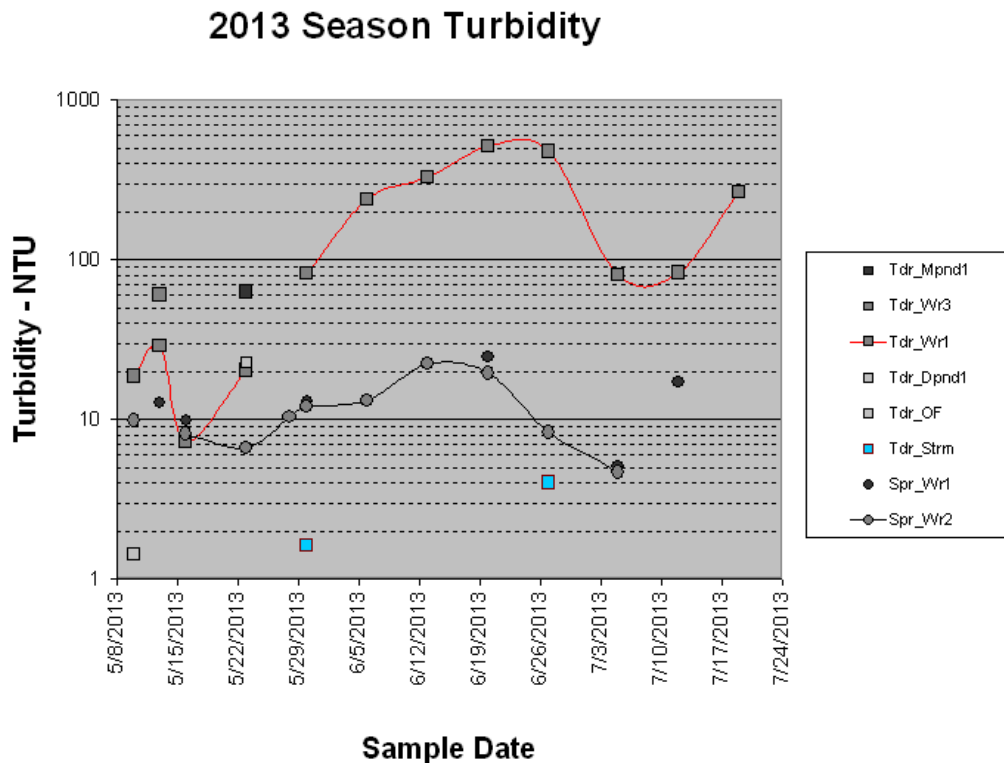
Figure 7: Turbidity in meltwater at 2013 snow sites

Turbidity at Tudor was markedly poorer than that observed at Spruce throughout the 2013 melt season. Turbidity was variable in the early season then rose dramatically, peaking at over 500 NTU by the end of June. By early July the site had improved but experienced another rise in turbidity in mid-July when field observations in 2013 ceased. In fact, turbidity performance at this site overall approximated that of flat-pad snow disposal sites assessed originally by WMS in the late '90's. Fortunately, this site does not discharge surface flows to receiving waters so that the poor turbidity performance does not present an immediate water quality concern.

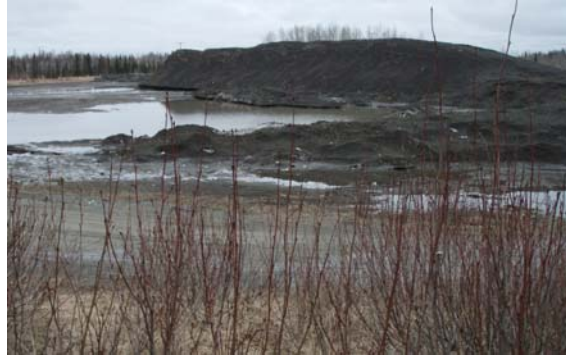
Figure 8: Snowfill 'wings' blocking lateral channels at Tudor site

Later, about a third of the way up the swales, snowfill was placed at twice that depth or deeper. Deep snowfill was also placed across lateral channels at several locations along the V-swales. Finally, near the end of the winter hauling season, snow was placed in massive 'wings' across the outer channels along the outside perimeter of the site's two main V-swales, combining with the central snow mass to form a crescent of deep snow wrapping around the central, upslope portion of the site (Figure 8).

As seasonal melt began, the outer wings of this crescent, underlain now by basal ice, dammed meltwater in a large pond above the main snow mass. The pond, blocked from the lateral channels by the 'wings' of snow placed in the lateral channels, grew sufficiently in size in the early melt season to flow down one of the site's access road. Eventually the basal ice under each of the outer crescents of snow failed, releasing a catastrophic flood of ponded meltwater down the lateral channels over a period of just a few hours. The abrupt release sent a very large flow down the unarmored channels, gouging sediment from the channel bottoms and their containing berms. The bends imposed on these channels by the V-swale asymmetry further increased scour due to directional and momentum changes. In this case the large mass of scoured sediment did not leave the site but the effects were measurable as the large increase in turbidity observed in mid-June.

- realignment of V-swales to reduce width asymmetry,
- reconstruction of axial and lateral channels including use of washed rock placed at or just above the pad surface elevation,
- construction of subdrains along lateral channels,
- armoring of the base of containment berms,
- replacement of discharge weirs including use of buried seepage cutoff walls,
- resizing of the detention pond to match source snow and volume, and
- re-grading and armoring of all discharge channels including those running from V-swale discharge weirs to the detention pond.

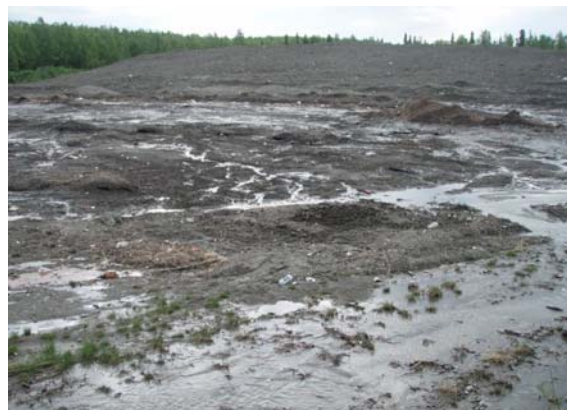
Figure 9: Collapse and exposure of downslope sediments to upslope meltwater at Tudor site

The non-uniform snowfill and in-filled, asymmetric V-swales also contributed to the mid-season elevated turbidity and the abrupt increase in turbidity observed at this site in early July. The thin snowfill at the lower end of the V-swales melted out much sooner than the deep mass of snowfill placed near the middle of the pad. When the thinner snow had collapsed onto the pad surface downslope of the remaining thick snowfill, the loose saturated dirt, now released to the pad surface, became subject to erosion by meltwaters from the snowfill remaining upslope (Figure 9). Erosion of the

downslope sediments were pronounced and are reflected in the rising turbidity measured at the end of the season at this site. In any event, the poor performance observed at Tudor in 2013 does not so much discredit the utility of the V-swale concept (particularly given its stellar performance at Spruce) as provide a useful reminder of the importance of

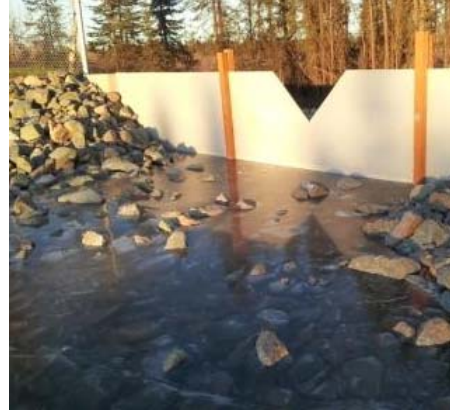
Figure 11: Fall ice depleting dry volume of Spruce detention pond

A major reason 2013 peak chloride concentrations may have been elevated relative to anticipated performance is likely reduction in designed dry capacity of the Spruce detention basin as a result of a considerable fraction of the total basin volume lost to ice frozen into the bottom of the basin early in the winter of 2012-2013 (Figure 11). At our 2012 pre-winter inspection, pond water from late fall rains had become frozen and occupied about 40% of the basin dry capacity as ice. A drain was installed as part of pond design to allow seasonal draining but the drain had been installed several feet above the pond bottom. The pond-bottom ice that had formed in the fall of 2012 did not thaw and lift from the pond bottom

until about mid-May, well after peak chloride leaching had taken place and discharge from the pond had begun. As a result the maximum opportunity for dilution of the early peak chloride release was lost and peak chloride concentrations discharged from the site were increased over what site design and 2013 conditions would predict. Chloride release under similar lost dry capacity conditions in a normal snowfall year could result in dramatic increase in peak chloride release to the eastern wetlands.

from both inundation and chloride can have a much larger effect than either individually. Given this, continued good operation of this site and repair of the pond drain to ensure that optimum dry capacity is present prior to freezeup will be critical to achieving continuing minimal impact to the receiving wetlands.

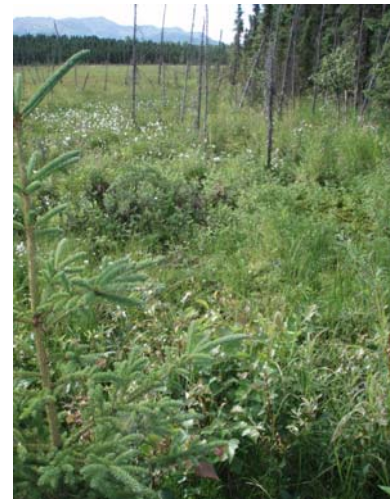
Figure 12: Inundation effects on spruce trees at Spruce outfall

In any event chloride impacts to the receiving wetlands appeared de minimis in 2013. Visual inspection of measurements made after leafout (late May-early June) of chloride concentrations at the site outfall (Spr\_WR2), at points along the wetland discharge flow path, and at background locations suggest no apparent difference between wetland waters along the discharge flow path and at background locations (Figure 10). Small-sample Wilcoxon rank-sum tests comparing measurements along the wetland discharge flow path and background wetland locations also suggest no difference in sampled populations. Chloride concentrations measured at these location in 2013 were also well below chronic and acute thresholds recommended by Chmielewski et. al. (1998) for wetlands receiving snowmelt from Anchorage snow disposal sites. They and others (Hansen, 2001) point out that brief exposures to modest chloride concentrations early in Anchorage's growing season may not normally represent a practicable threat to wetland plant ecosystems. However this is dependent upon chloride type (with a magnesium chloride type that is predominant at this site representing a larger threat) and extent and duration of inundation. Prolonged seasonal inundation has long been in effect at these wetlands due to damming of area snowmelt against an access road crossing the drainage path of the wetlands. Dead spruce trees (snags) seen in Figure 12 near wetland sampling station Spr\_Wet0 and immediately adjacent to the site outfall were present at the time of site construction and are likely the result of this seasonal history of inundation. However, as Chmielewski et. al. (ibid.) points out, combined stresses

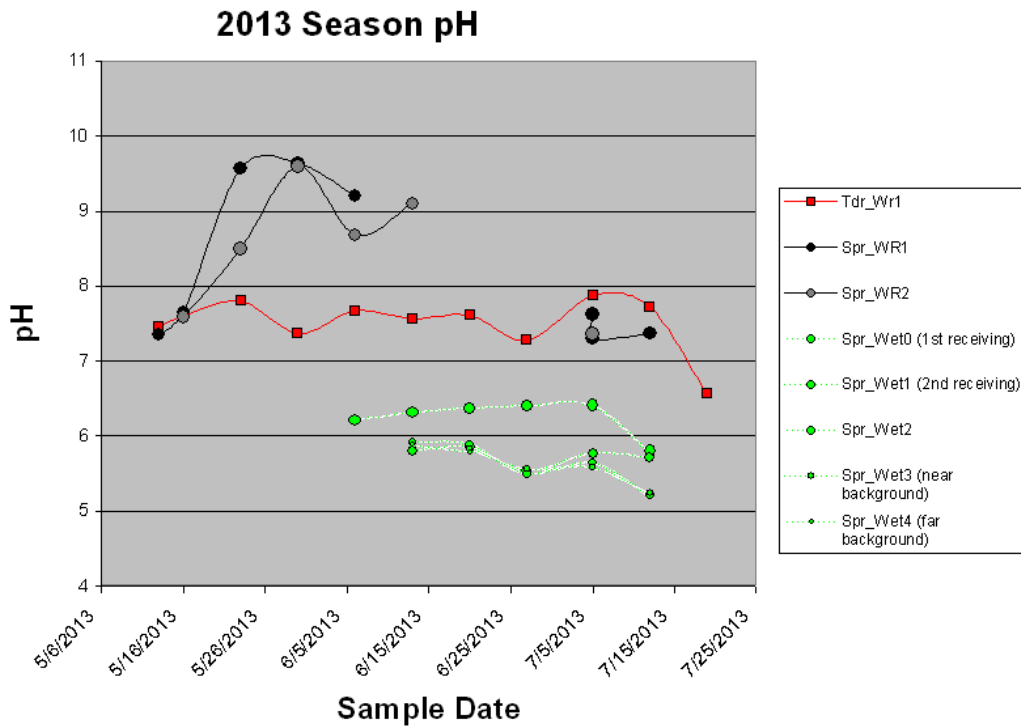
Figure 13: pH in snow meltwater at 2013 sites

Finally, we measured the pH of site meltwaters at both sites during our 2013 investigation (Figure 13). The pH of meltwaters at the Tudor site was uniform and approximately neutral throughout the investigation, reflective of all previous measurements WMS and others have made of meltwaters at Anchorage snow disposal sites. This was mysteriously not the case at the Spruce site. Early in the season pH at Spruce closely matched our results at Tudor but in mid-May pH rose sharply and then began a gradual decline. By the end of the season the pH of both pond and site discharge waters had re-attained a pH characteristic of meltwater from Anchorage snow disposal sites. During the rapid pH rise, samplers measured meltwater flowing across the pad surface as it originated from the snowfill and from ponded water impounded on the pad upgradient from (above) the detention pond. All these measurements showed near neutral pH so that we excluded the snowfill itself as a source of the high pH.

excluded this as a likely source. Very rapid onset of the pH rise coincident with spring release of the ice frozen to the pond bottom suggested subdrain materials or the GCL as the most probable source of the elevated pH. In any event, pH declined steadily over the spring and summer and reached neutral conditions by mid-summer. Inspection of pH measurements made along the wetland discharge flowpath and at background locations suggest that pH of the wetlands became moderately elevated near the point of meltwater discharge to the wetlands (Spr\_Wet0). However, northern wetlands typically have a high buffering capacity (Post, 1996). By the middle of the summer the plume of elevated pH had substantially attenuated as evidenced by serial changes in pH measured at Spr\_Wet0 and Wet1. Given the exclusion of the snowfill as a source and the steady decline of pH in the meltwaters to a more typical neutral level, we believe that an interpretation of new construction materials as a source to be a reasonable inference. Additional monitoring could readily confirm this. However for the long-term, we do not anticipate meltwater pH values at this site that are markedly different from those at other Anchorage snow disposal sites.
