2015 ANNUAL MEETING SUMMARY
APDES Permit No.
AKS-052558 February 25, 2015

<p>Municipality of Anchorage</p>

Watershed Management Services
Project Management and Engineering Division
Municipality of Anchorage

2015 Watershed Update

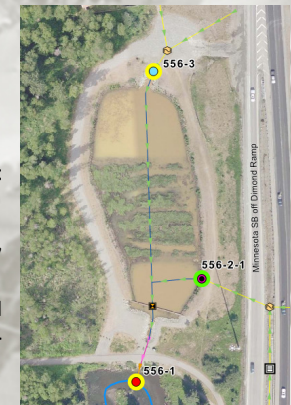
Sample results showed an exceedance for fecal coliform at an outfall of a sedimentation pond on Campbell Creek.

- Initial sample result: 413 cfu/100 mL
- Follow-up sample result of sed. pond outfall (556-1): 327 cfu/mL
- Follow-up sample result on outfall draining into sed. pond (556-3) to track potential up-network contamination: non-detect

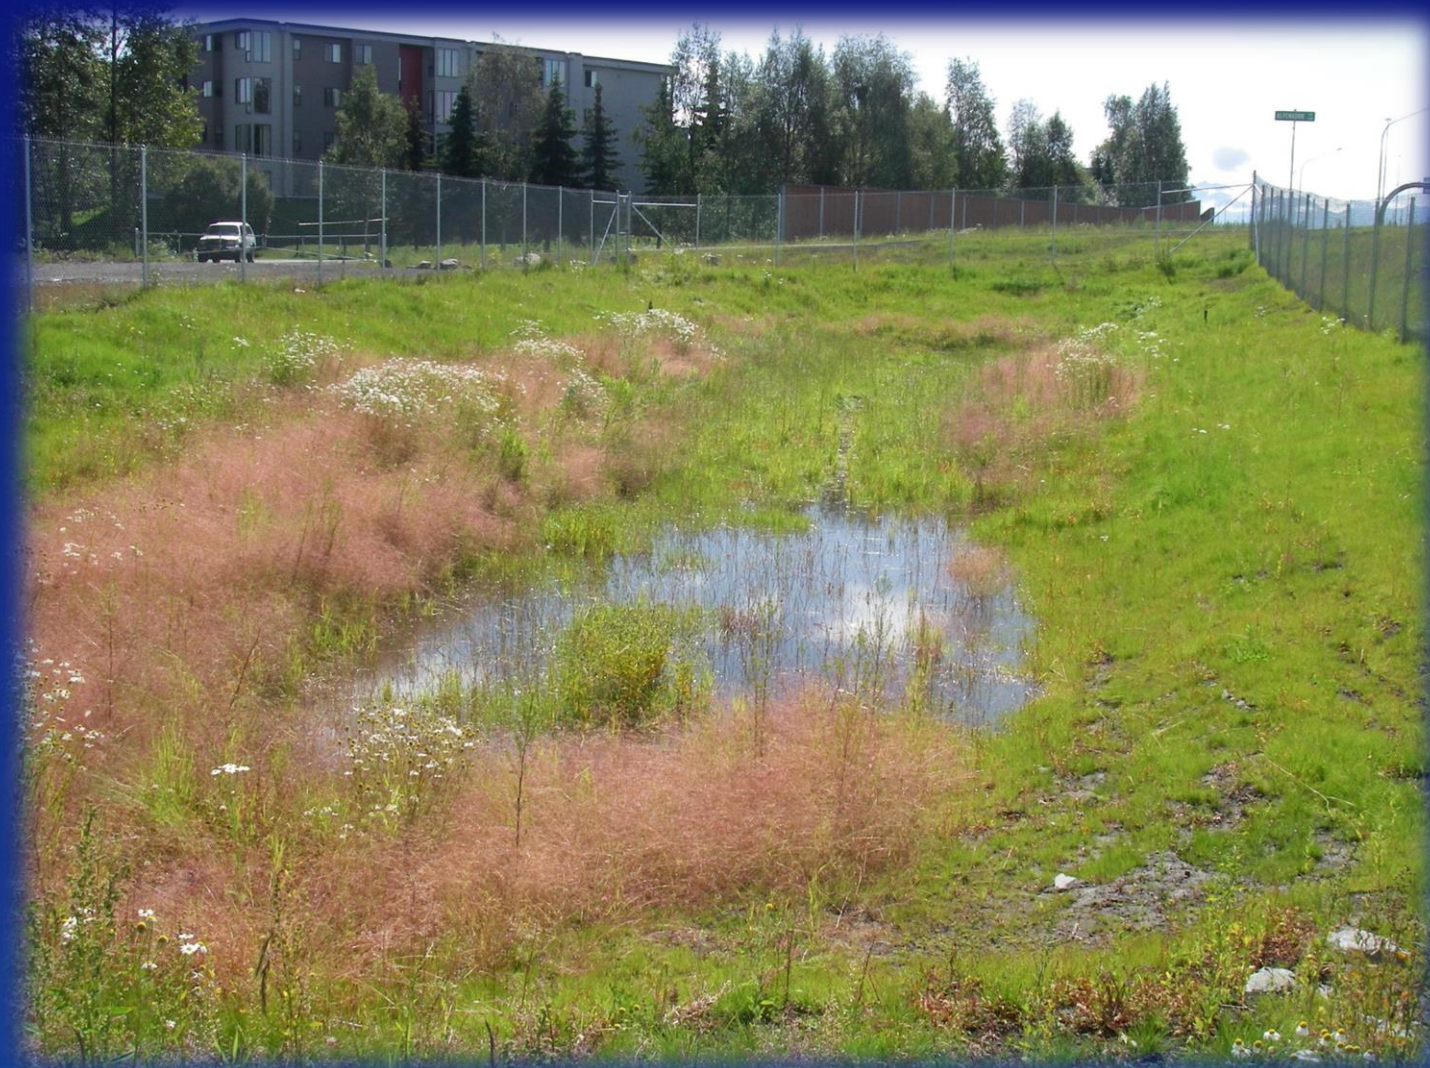
NSH Infiltration Basin

ADOT&PF recently widened the New Seward Highway (NSH) from Dowling Rd to Tudor Rd, and used LID techniques to manage stormwater. Runoff from a significant portion of the roadway improvement area (about 9.4 acres with 6.7 acres of impervious surface) was directed to an infiltration basin. The basin collects and infiltrates small rainfall events and allows larger events to overflow to an adjacent ditch that flows to Campbell Creek. The basin was designed to collect and infiltrate runoff from design events up to the 90th percentile event—0.52 inches of rain in 24-hours. The basin is approximately 150 feet long and 45 feet wide, with gentle side slopes and an average depth of two feet. The basin inlet is a 24-inch diameter culvert on the southwest side of the basin, and the outlet is a small earthen berm on the north side.

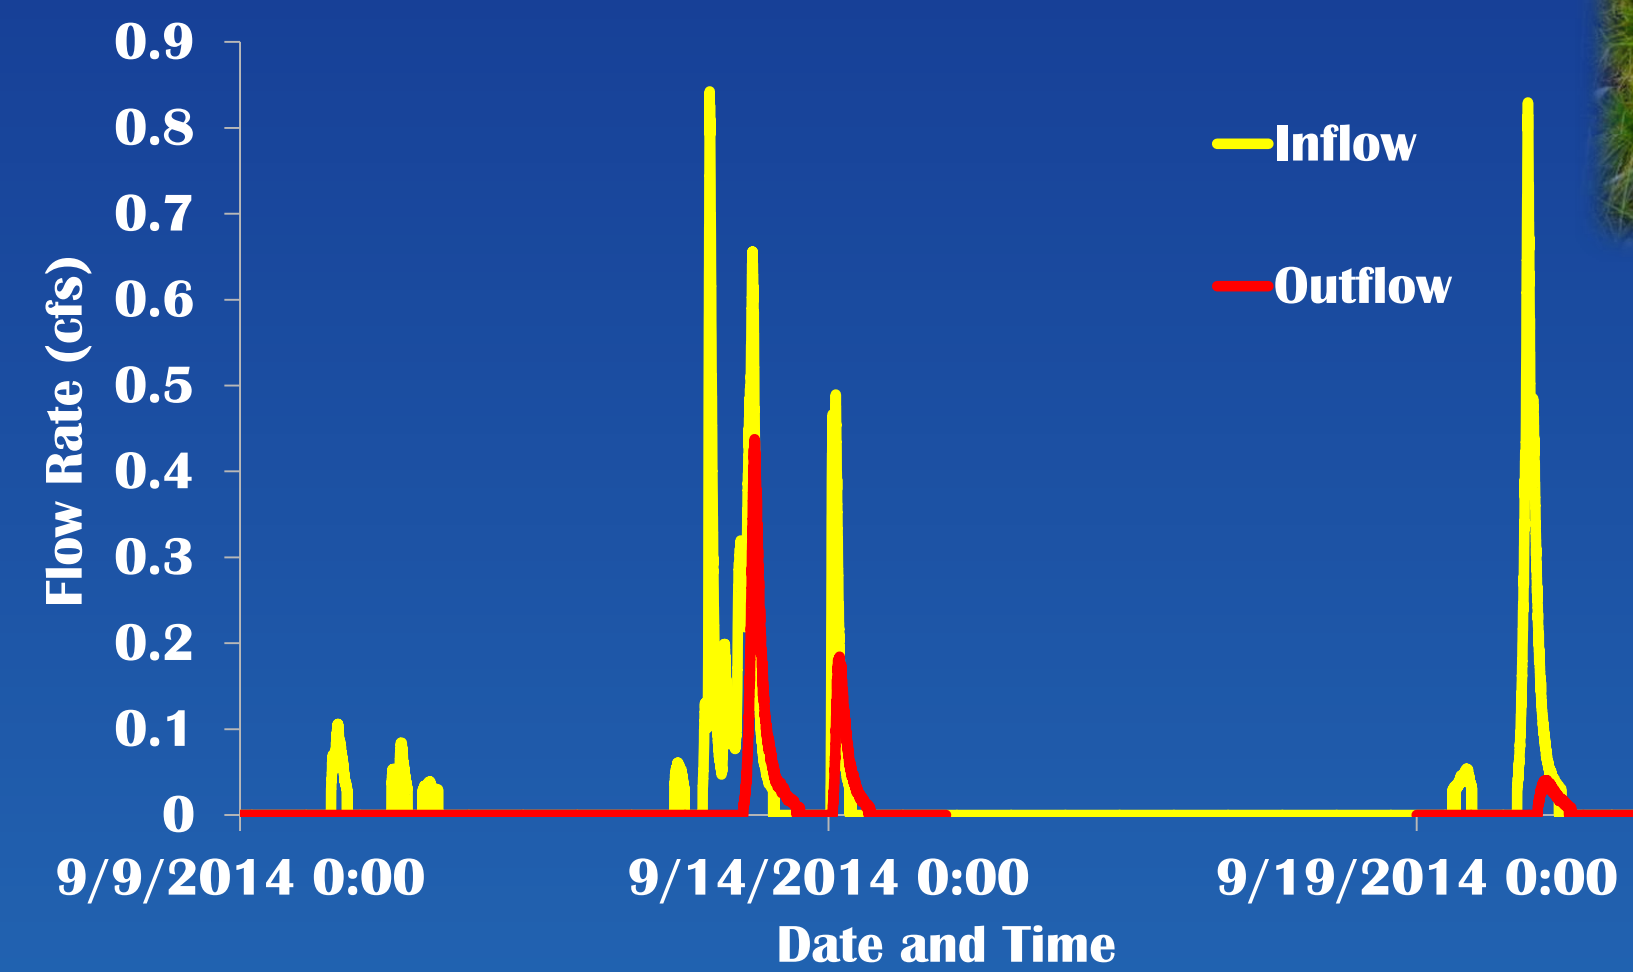
The graph above shows the basin's inflow and outflow hydrographs for a 12-day period of rain. On Sept 13, 0.35 inches of rain fell in one hour.

Monitoring In order to determine how well the basin was performing at retaining and attenuating flows, the basin inflow and outflow were measured using 90-degree, v-notch weirs and pressure transducers. By comparing inflow and outflow, we can determine the amount of water stored/infiltrated by the basin. Data was collected from July to October of 2014. The monitoring results showed that for the entire recording period, the basin only produced an outflow three times, during a 12-day rainy period.

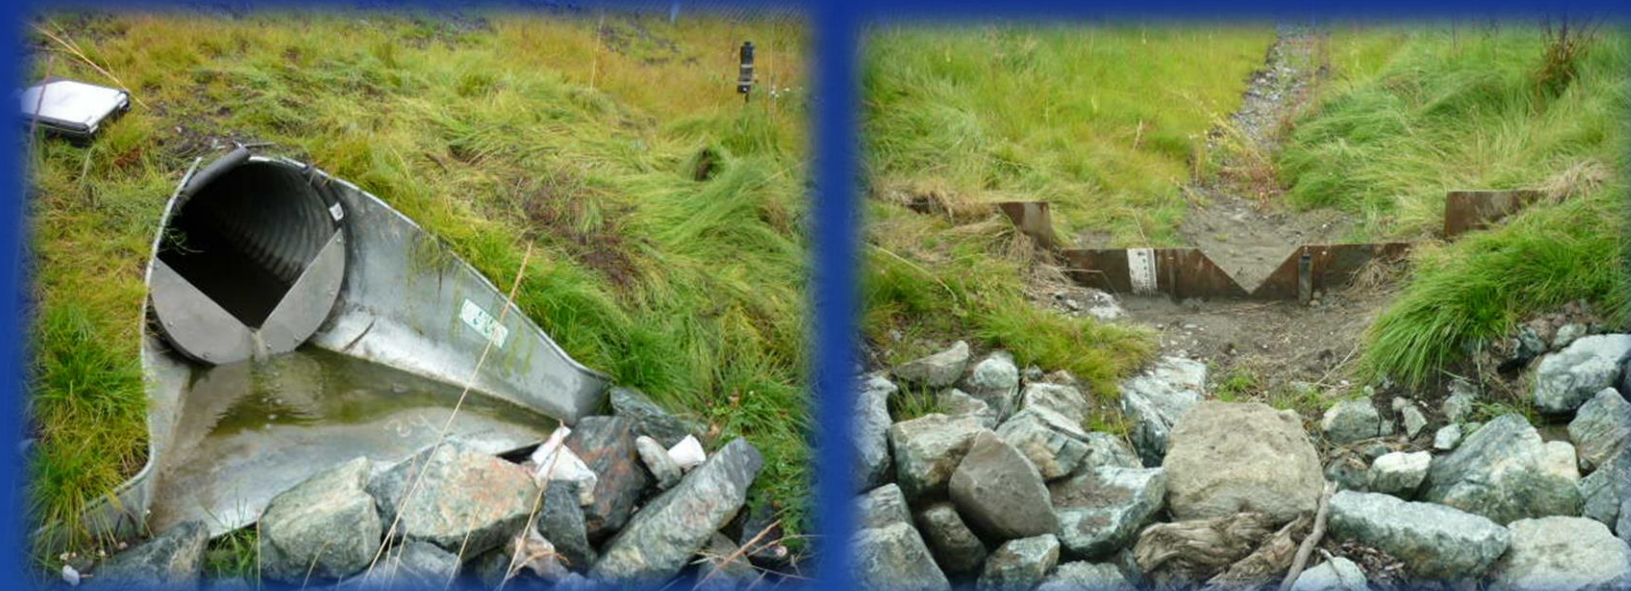
Basin inlet (left) and outlet (right)

Native Soils Percolation testing was done before construction of the basin and resulted in per rates ranging from 2.1 to 6.3 inches per hour. These are average to moderately low infiltration rates for the Anchorage area. Interestingly, the infiltration basin was used as a sediment trap during construction, which is expected to have further reduced its infiltration capacity. Despite these limitations, it is out-performing design expectations.

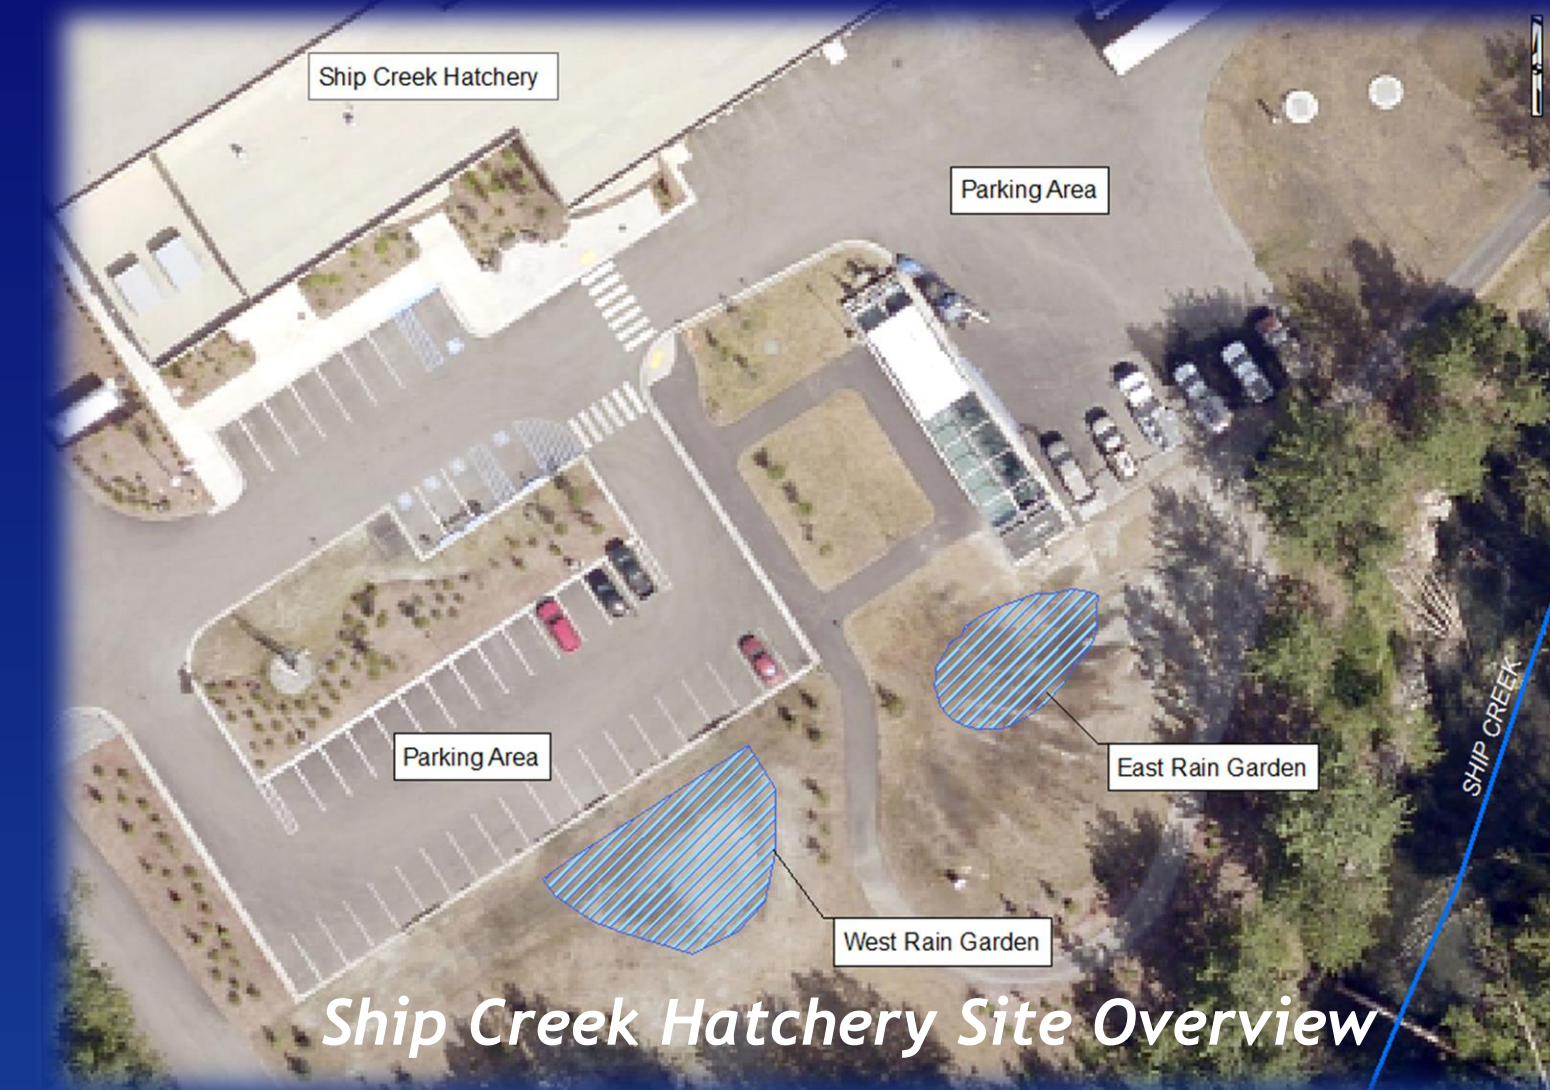
The parking lot of the Ship Creek Hatchery was reconstructed as part of a project that converted the old site into a hatchery in 2011. The hatchery is located immediately adjacent to Ship Creek, and the entire site design is centered around minimizing direct stormwater runoff to Ship Creek. The topography of the site's green areas are contoured to capture water, and flat curbs are used in lieu of traditional curbs around parking lot landscape features to allow stormwater from pavement to flow into the landscaping. The site includes two primary landscaped rain gardens, which were the focus of this monitoring effort.

Monitoring The rain gardens were monitored from July to October of 2014. The sheet/overland inflow & outflow made on-site instrumentation impractical. Instead, inflow hydrographs were developed using EPA's Storm Water Management Model (SWMM) with rainfall data from Merrill Field Airport. Outflow was determined by comparing inflow volume to the design capacity of each rain garden, and was confirmed through on-site inspection during or following significant rain events. The results show that the design capacity of the rain gardens was not exceeded during the monitoring period. In other words, there was no outflow from either garden. This was verified by visual inspection.

Rain Gardens The two rain gardens collect runoff from approximately 18,850 sf of parking lot. The rain gardens are designed to accept and infiltrate small storm events and bypass larger events. Water that enters the rain gardens but is not infiltrated is allowed to overflow the earthen sides of the gardens. Overflow is directed to Ship Creek via overland flow. Both rain gardens are fully vegetated with grass-like vegetation.

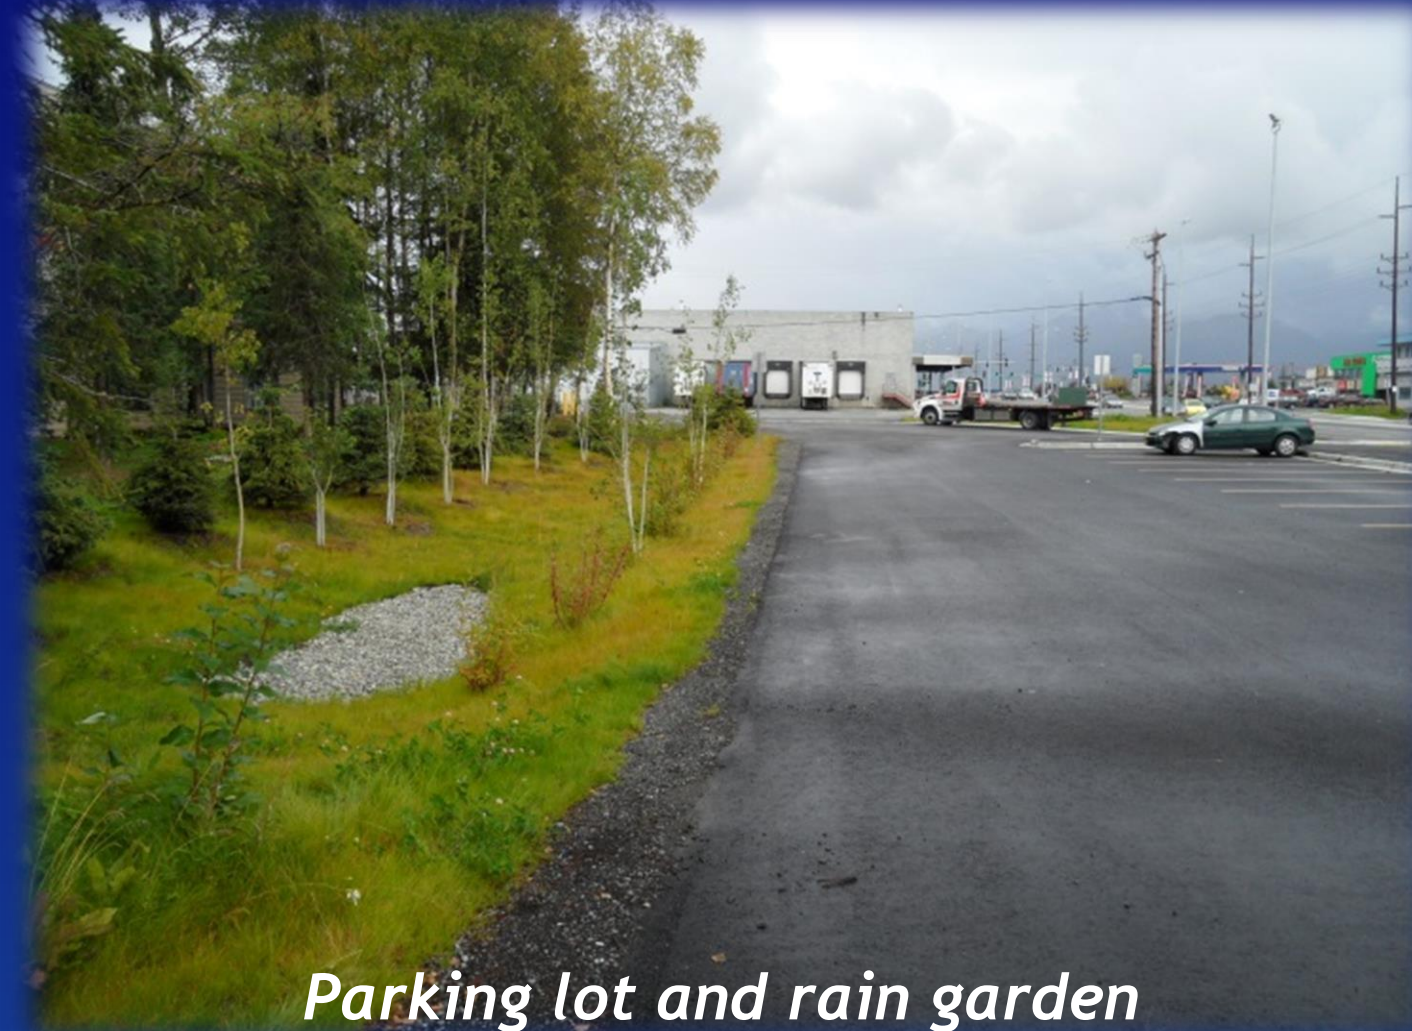
Parking lot and rain garden

The West Dowling parking lot is located on the north side of West Dowling Rd, west of the intersection of West Dowling Rd and the Old Seward Highway. The parking lot is immediately adjacent to Campbell Creek and provides public parking access for users of the popular Campbell Creek trail. The area was re-constructed when West Dowling Road was widened in 2012. Runoff from the 8,600 sf parking lot flows to a rain garden that provides infiltration of small to mid-size storm events, with an overflow for larger events. Water enters the rain garden via sheet flow from the parking lot. The outlet is an earthen berm, and overflow from the rain garden is directed to Campbell Creek.

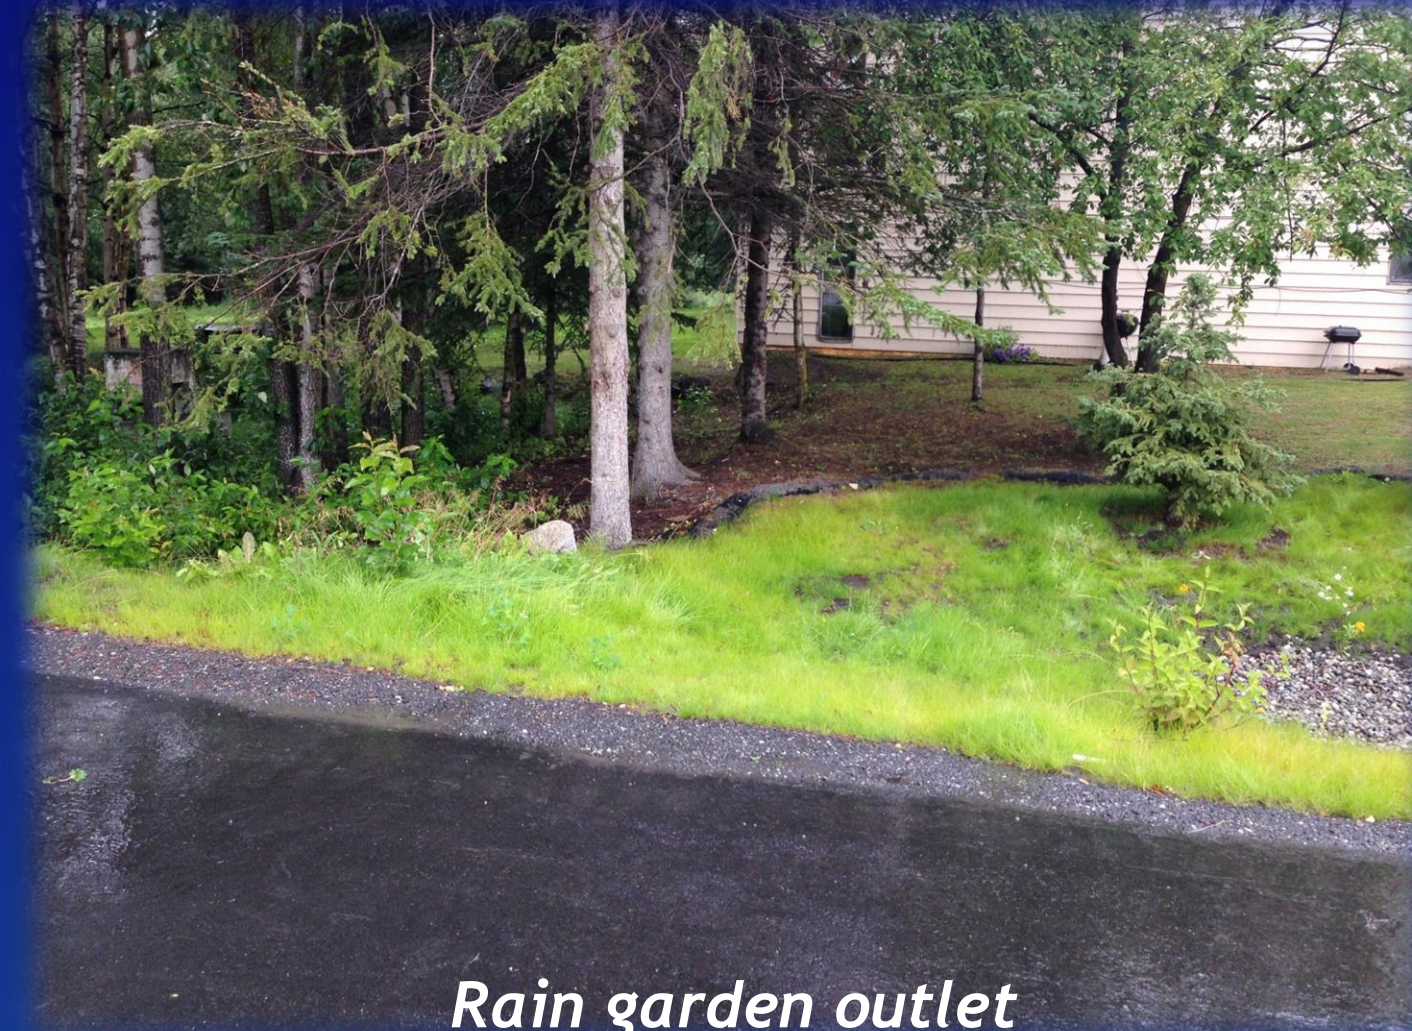
Rain garden outlet

Monitoring The rain garden was monitored from July to October of 2014. The inflow and outflow characteristics of this garden made on-site instrumentation impractical. Instead, inflow hydrographs were developed using EPA's Storm Water Management Model (SWMM) using rainfall data from Anchorage International Airport. Outflow was determined by comparing inflow volume to the design capacity of the rain garden, and was confirmed through on-site inspection during or following significant rain events. The results show that the combined storage capacity and infiltrative capacity of the rain garden were not exceeded during the monitoring period. In other words, there was no outflow from the garden. This was verified by visual inspection.

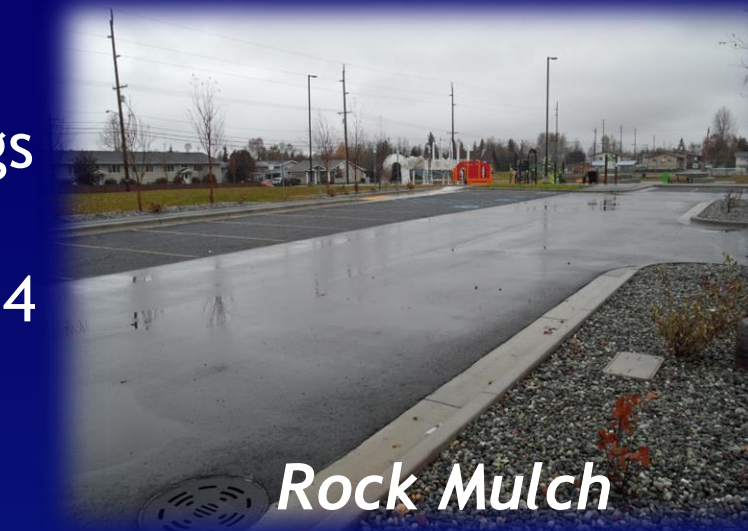
Rock Mulch

Woodchip mulch (shown on the right above) was migrating from landscape planters, being crushed by traffic, and clogging the asphalt pores. The woodchip mulch was replaced with rock mulch in some areas and grass seeding in other areas. The parking lot was swept to prevent the problem from worsening.

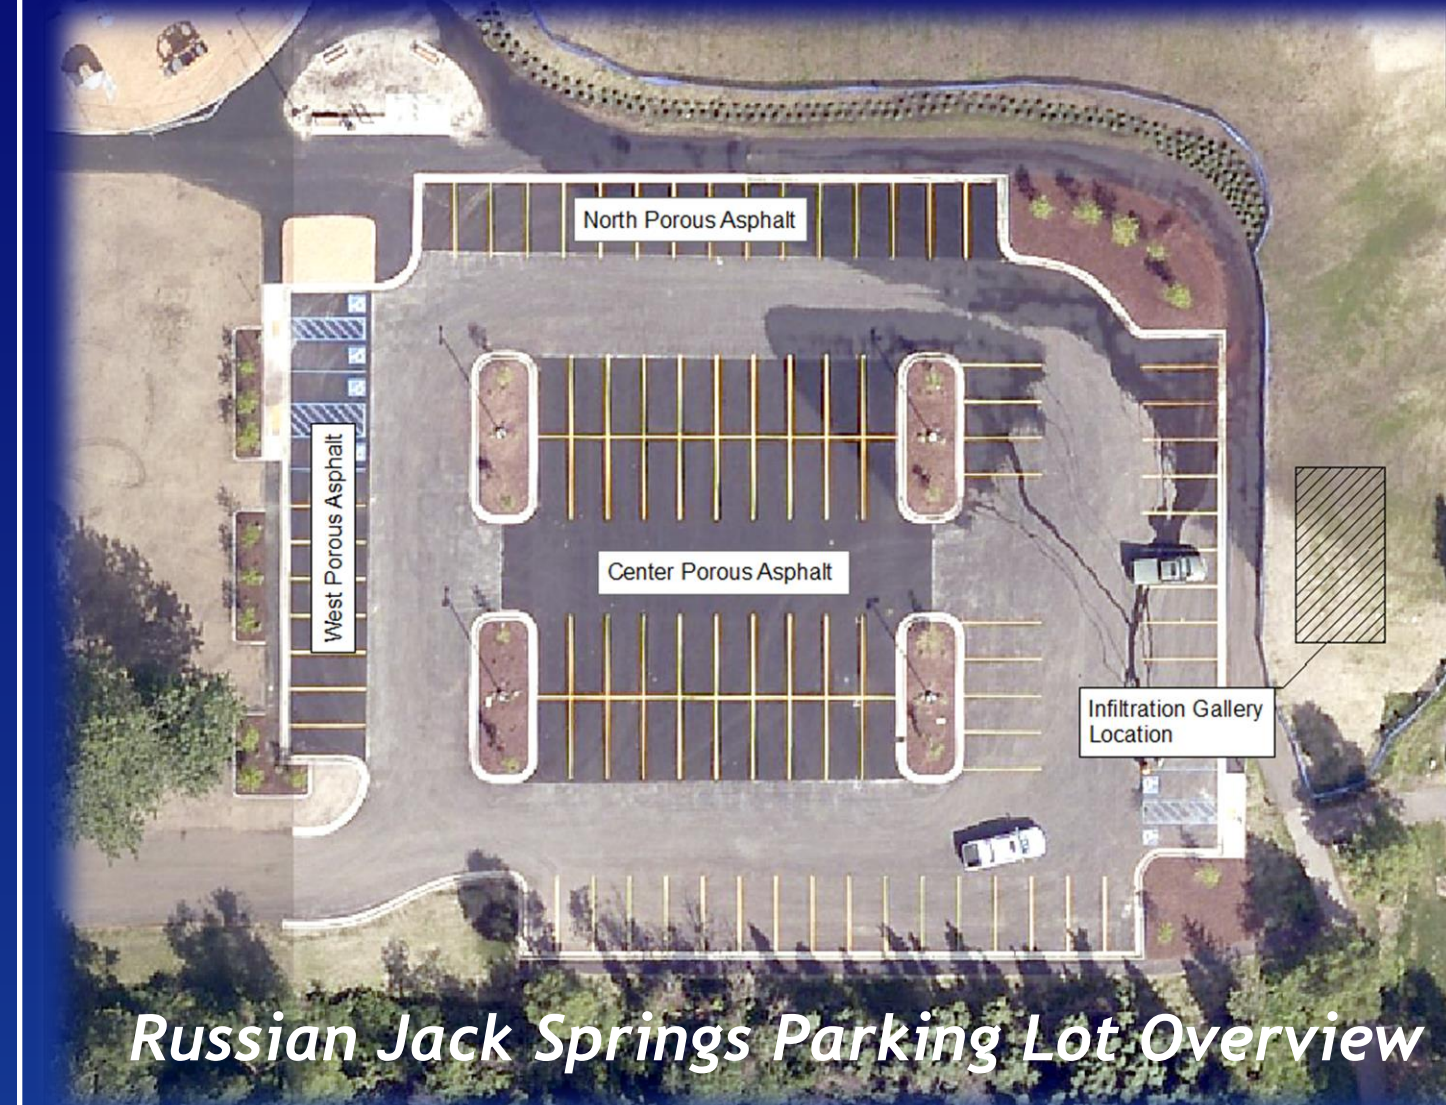
Russian Jack Springs Parking Lot Overview

Porous Asphalt The MOA continued visual monitoring of the porous asphalt at Russian Jack Springs Park parking lot. The one-acre parking lot includes a combination of traditional and porous asphalt. The 2014 monitoring identified some maintenance concerns that were addressed to help ensure asphalt longevity.

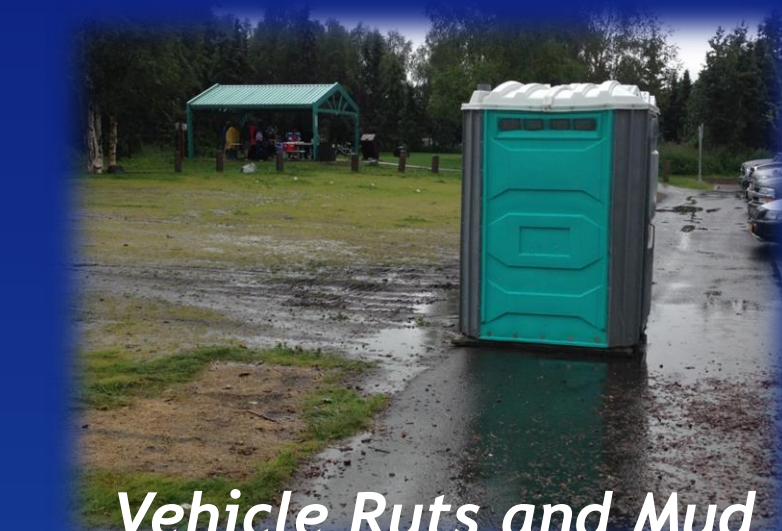
Vehicle Ruts and Mud

Infiltration Gallery Unauthorized vehicular access to the area east of the parking lot caused the ruts and mud seen in the above photo. This area is upstream of the infiltration gallery and the mess created concern for sediment loading of the gallery. To remedy the problem, the area was blocked from future access and re-seeded.

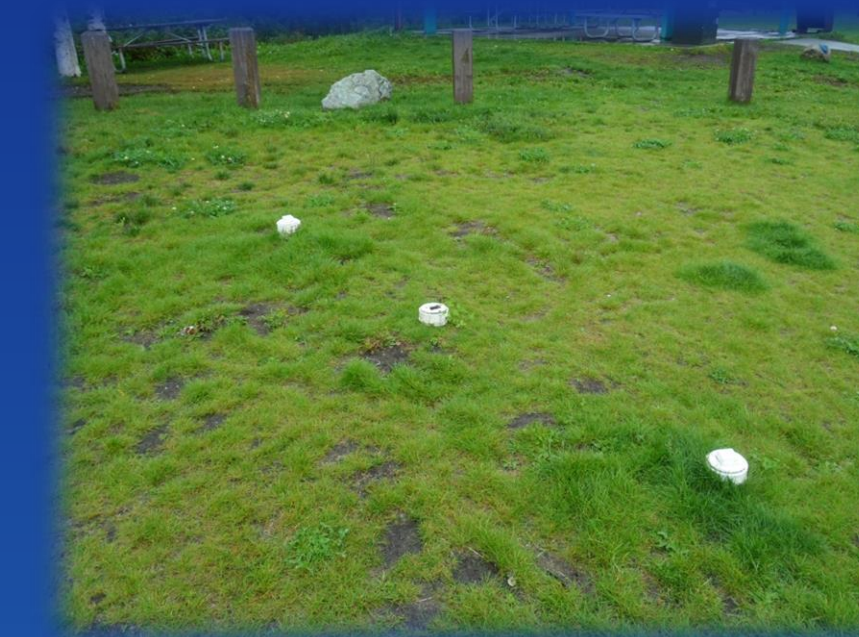
The infiltration gallery, shown to the left, did not show signs of decreased performance. Water levels were checked during or immediately following three significant rainfall events, and standing water was not observed.

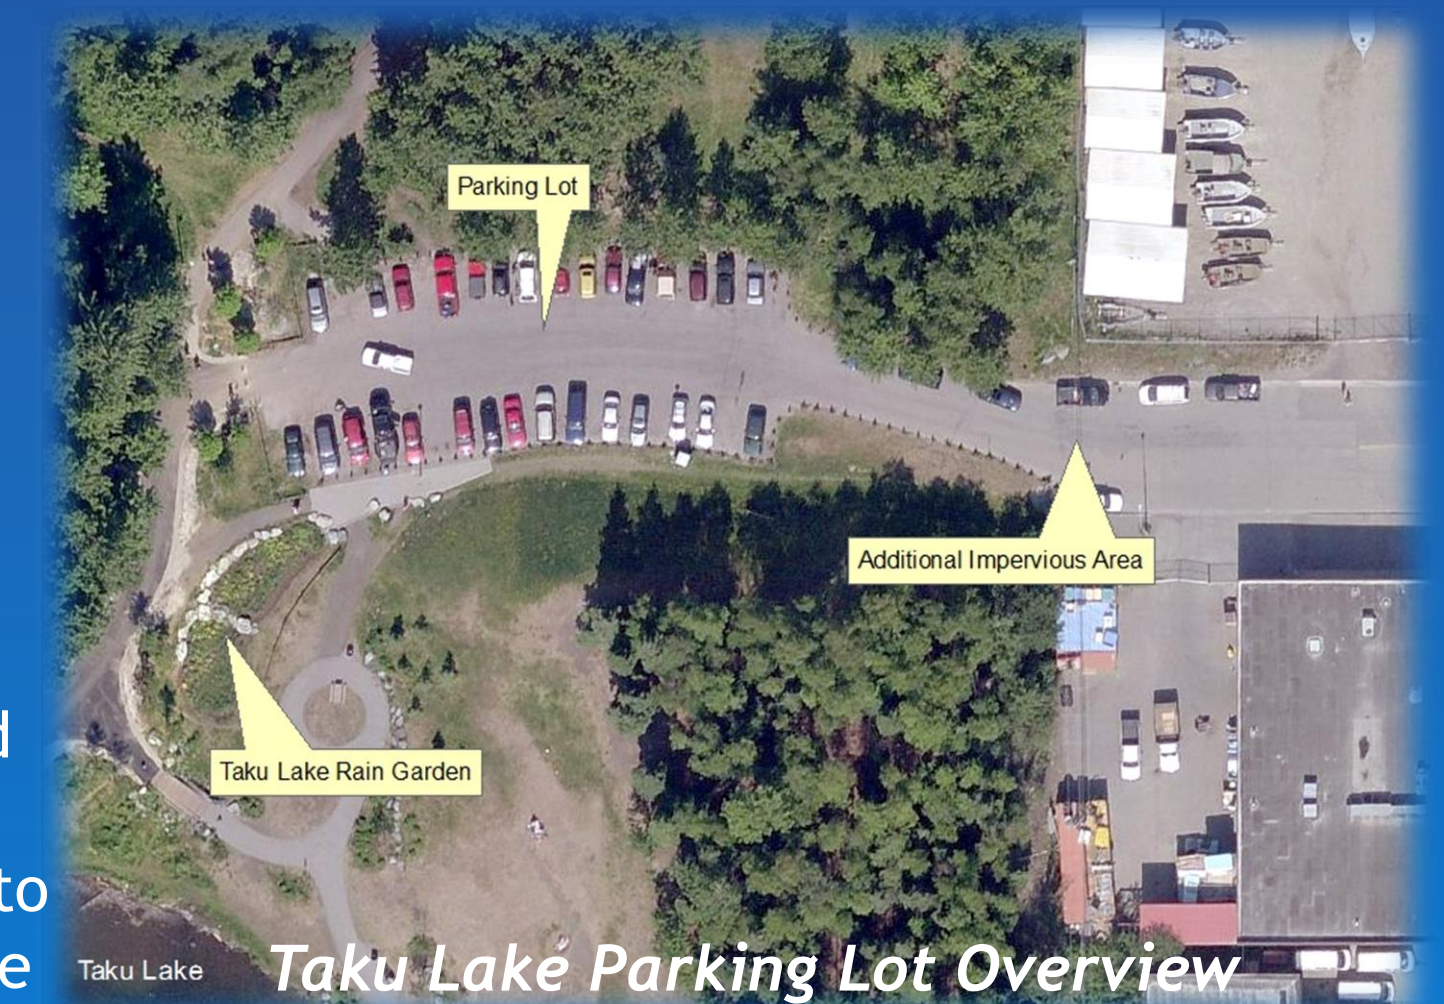
Taku Lake Parking Lot Overview

The MOA continued visual monitoring of the rain garden at Taku Lake Park. The parking lot accepts stormwater runoff from the Taku Lake parking area (12,150 sf) as well as a portion of King St. The rain garden provides treatment and retention of small storm events through plant uptake, top soil saturation, and infiltration. Excess water is collected in a perforated subdrain which outlets near Taku Lake.

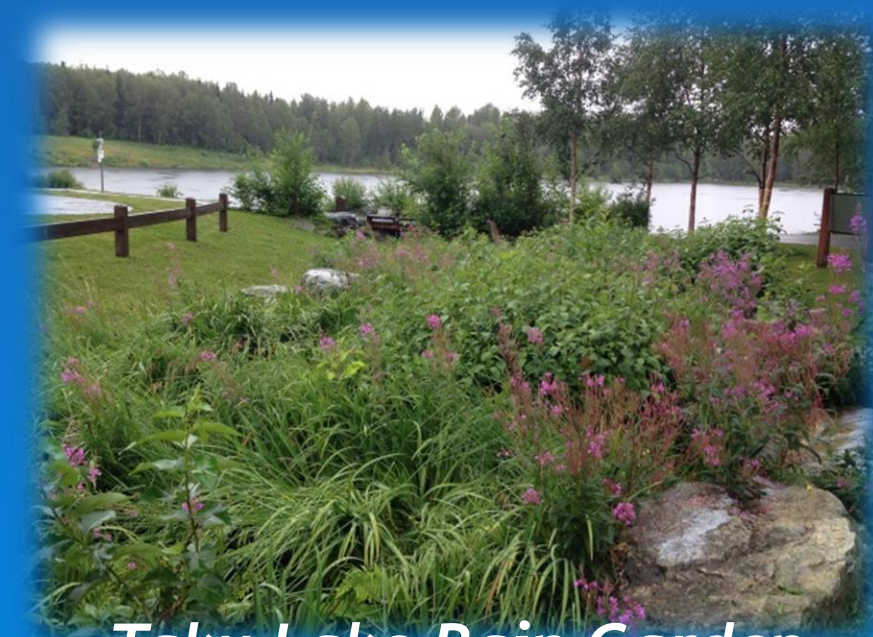
Taku Lake Rain Garden

The monitoring results showed that the rain garden is performing well. It continues to provide infiltration and storage for small rain events, and detention of larger events. Outflow from the rain garden's underdrain was only observed once and that was during the site visit on July 25. The July 24-25 event produced 1.46 inches of rain and rain garden outflow is expected under these circumstances.
