2017 SWM07 Stormwater Outfall Monitoring Report

APDES Permit No. AKS-052558

MUNICIPALITY OF ANCHORAGE
WATERSHED MANAGEMENT
SERVICES

INTERIM PROGRESS REPORT

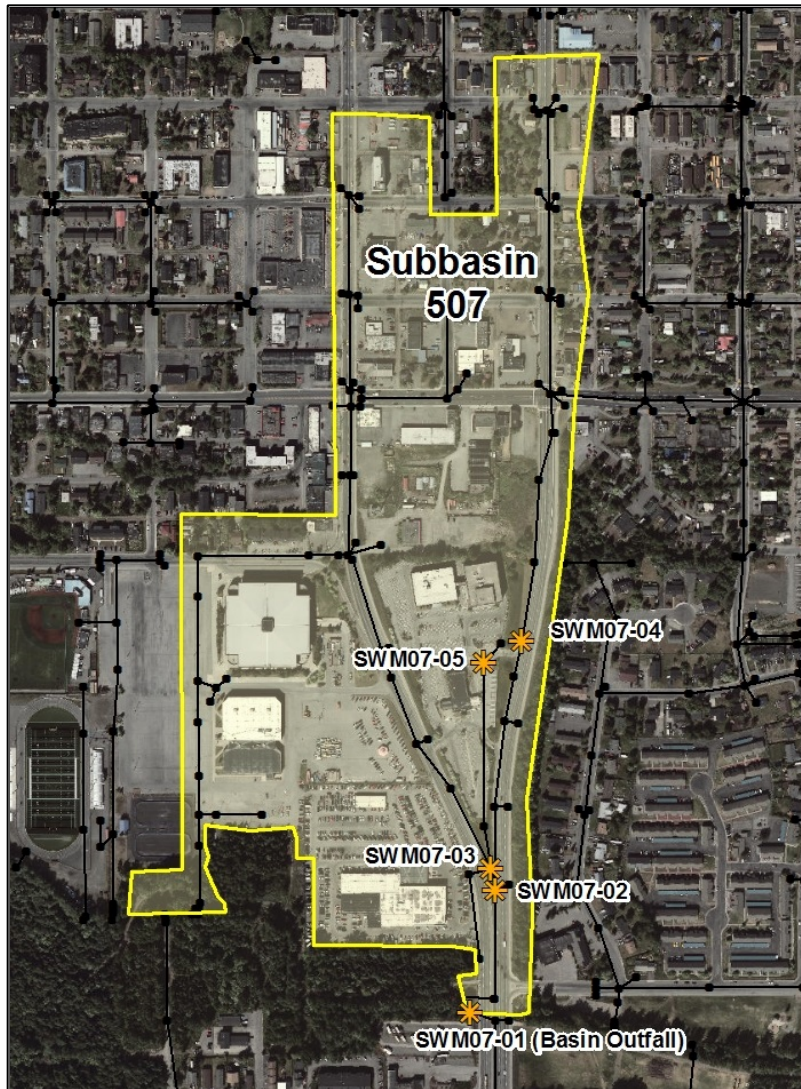
Figure 1. Subbasin 507 Boundaries and 2017 Sample Locations.

Stormwater Outfall SWM07 drains MOA Drainage Subbasin 507. The subbasin is approximately 75 acres in size. Geographically, the basin stretches from 12th Avenue southward to Chester Creek and from slightly west of Gambell Street, to just east of Ingra Street. In general terms, the basin drains the “wye”-shaped road split at the terminus of the Seward Highway in the vicinity of the former Cal Worthington Ford and the Sullivan Arena. Figure 1. shows the extent of the basin, as well as some of the other basin characteristics described in this section.

The basin consists almost entirely of impervious surfaces consisting of pavement and roofs. Vegetated surfaces are, for the most part, limited to intermittent stretches of grass along roadways. The greatest concentration of vegetation is located in between Ingra and Gambell, south of 15th Avenue. Land use consists almost entirely of commercial development, with many areas (the car dealership, the bank, the Sullivan arena, etc.) having large parking lots. There is a small amount of residential development on the very northern edge of the basin. There is very little open, un-vegetated, unpaved land area within the subbasin.

Topographically, the entire basin slopes from the north to the south. The basin is steepest at the north end, just south of 15th Avenue, but the southward gradient is obvious from any point on the ground. The natural drainage pattern has been reinforced by a constructed storm drain network. From the outfall the storm drain runs uphill and east to an oil and grit separator (OGS). The storm drain continues uphill to the north and uphill, eventually splitting into three branches. One branch, to the west, drains Gambell Street. One branch, to the east, drains Ingra Street. The third branch, in the middle, drains the area in between the two roads, in the vicinity of First National Bank

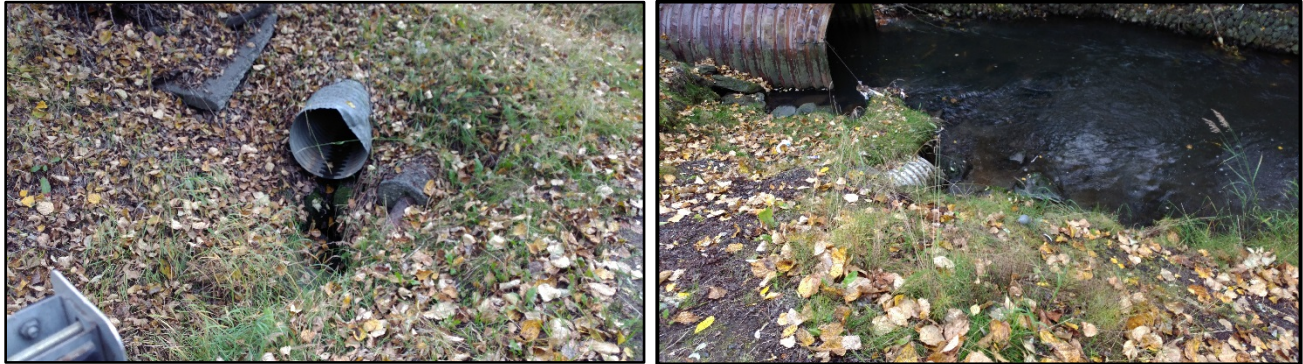
Figure 2. SWM07 Outfall Configuration.

of Alaska (FNBA) and the Green Connection. Along the two road ways catchbasins/catchbasin manholes are located on both sides of the roads, spaced every two hundred feet or so. The outfall configuration itself is fairly unique in that the stormdrain pipe projects out from the base of the road embankment. From there, water drops into a hole that flows into a second pipe running perpendicular to the main storm drain (and Chester Creek). This pipe empties into Chester Creek. The end of the outlet pipe is located in the actual creek and is partly filled with sediment and partially submerged (Figure 2.).
