Memorandum

To: Kirsti Bischofberger, Watershed Manager, Municipality of Anchorage
From: Janie Dusel, PE
Date: February 3, 2017
Re: 2016 Low Impact Development/Green Infrastructure Performance Monitoring

The purpose of this memorandum is to provide a summary of the 2016 Low Impact Development (LID) /Green Infrastructure (GI) performance monitoring completed by AWR Engineering for the Municipality of Anchorage (MOA).

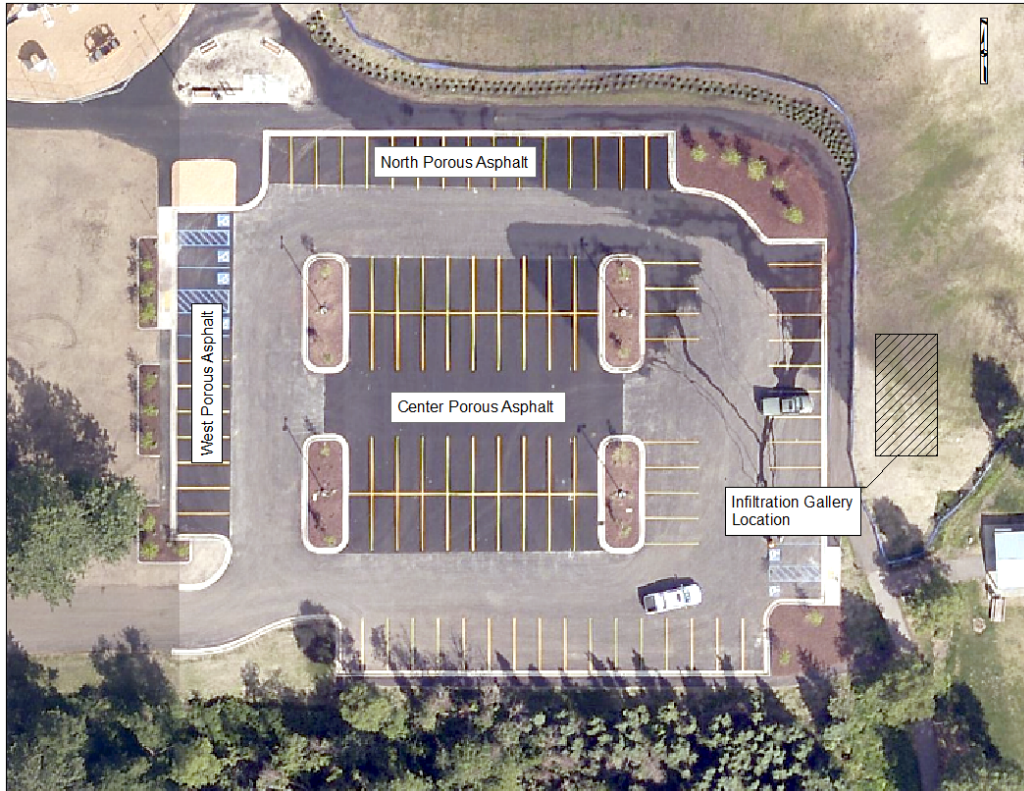
Figure 1: RJSP Parking Lot Layout

One area of the parking lot was also observed to be deeply rutted, potentially from construction support trucks accessing the skate park. Based on the expected parking lot use provided by the MOA Parks Department, the porous asphalt was not designed for heavy truck loading. The heaviest expected vehicle to utilize the parking lot was the truck that services the onsite porta potty.

Light surface raveling of the asphalt was noted in last year's monitoring report, and was observed to be continuing, though not significantly worsened from last year. As discussed in the 2015 report, the absence of frequent sweeping of the parking lot is expected to compound this issue because the unraveled rocks remain on the surface and are then ground into the remaining asphalt under vehicular traffic. Photos from the July 17 site visit are shown in Figure 4.

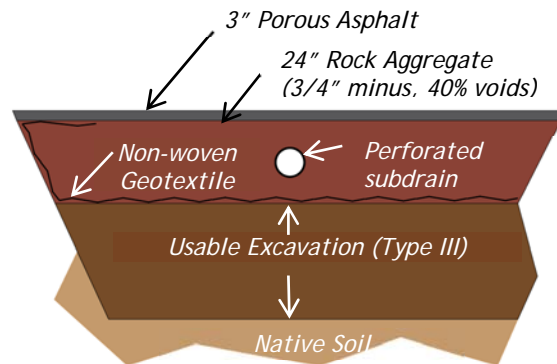
Figure 2: Typical Porous Asphalt Section

2016 Observations. In addition to the September 22 site visit, this site was visited on July 17, when no precipitation was occurring. Previous monitoring reports (2013 through 2015) have noted positive performance of this parking lot despite ongoing maintenance concerns, particularly with the porous asphalt. The 2016 observations continue this general trend. When the parking lot was visited on July 17, it was observed to be scattered with clumps of dirt and debris which were believed to be tracked onto the parking lot during construction of the Park's new skate park, just north of the parking lot. The parking lot also appeared to have been sanded during the winter and had not been swept. Sanding of the porous asphalt portions of the parking lot is not recommended unless frequent vacuum sweeping is completed. It appeared that sand had been placed on the two smaller portions of porous asphalt, and had been tracked throughout the parking lot. Sand, dirt, and organic debris on the porous asphalt can result in clogging of the asphalt pores, particularly without frequent vacuum sweeping.

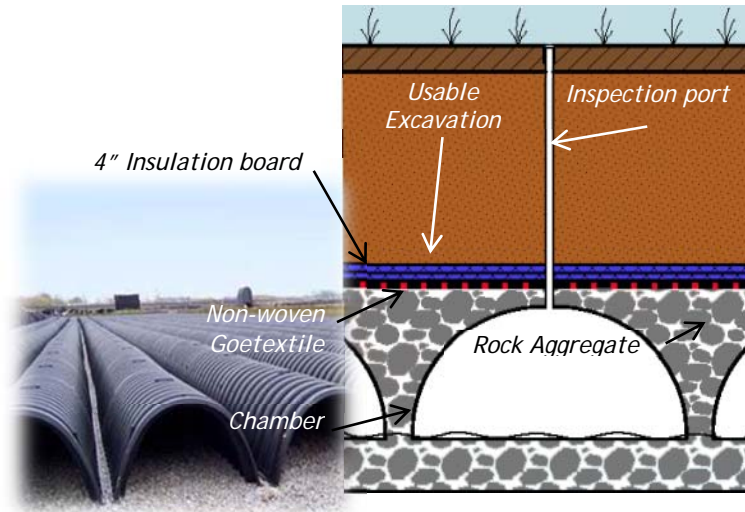
Figure 3: Typical Infiltration Gallery Section

The subsurface infiltration system was inspected via the chamber inspection ports, and standing water was not observed. This system is out-performing design expectations even with the addition of incoming flows from the east, which was not included in the design. Photos of the site from the September 22 site visit are presented in Figure 5.

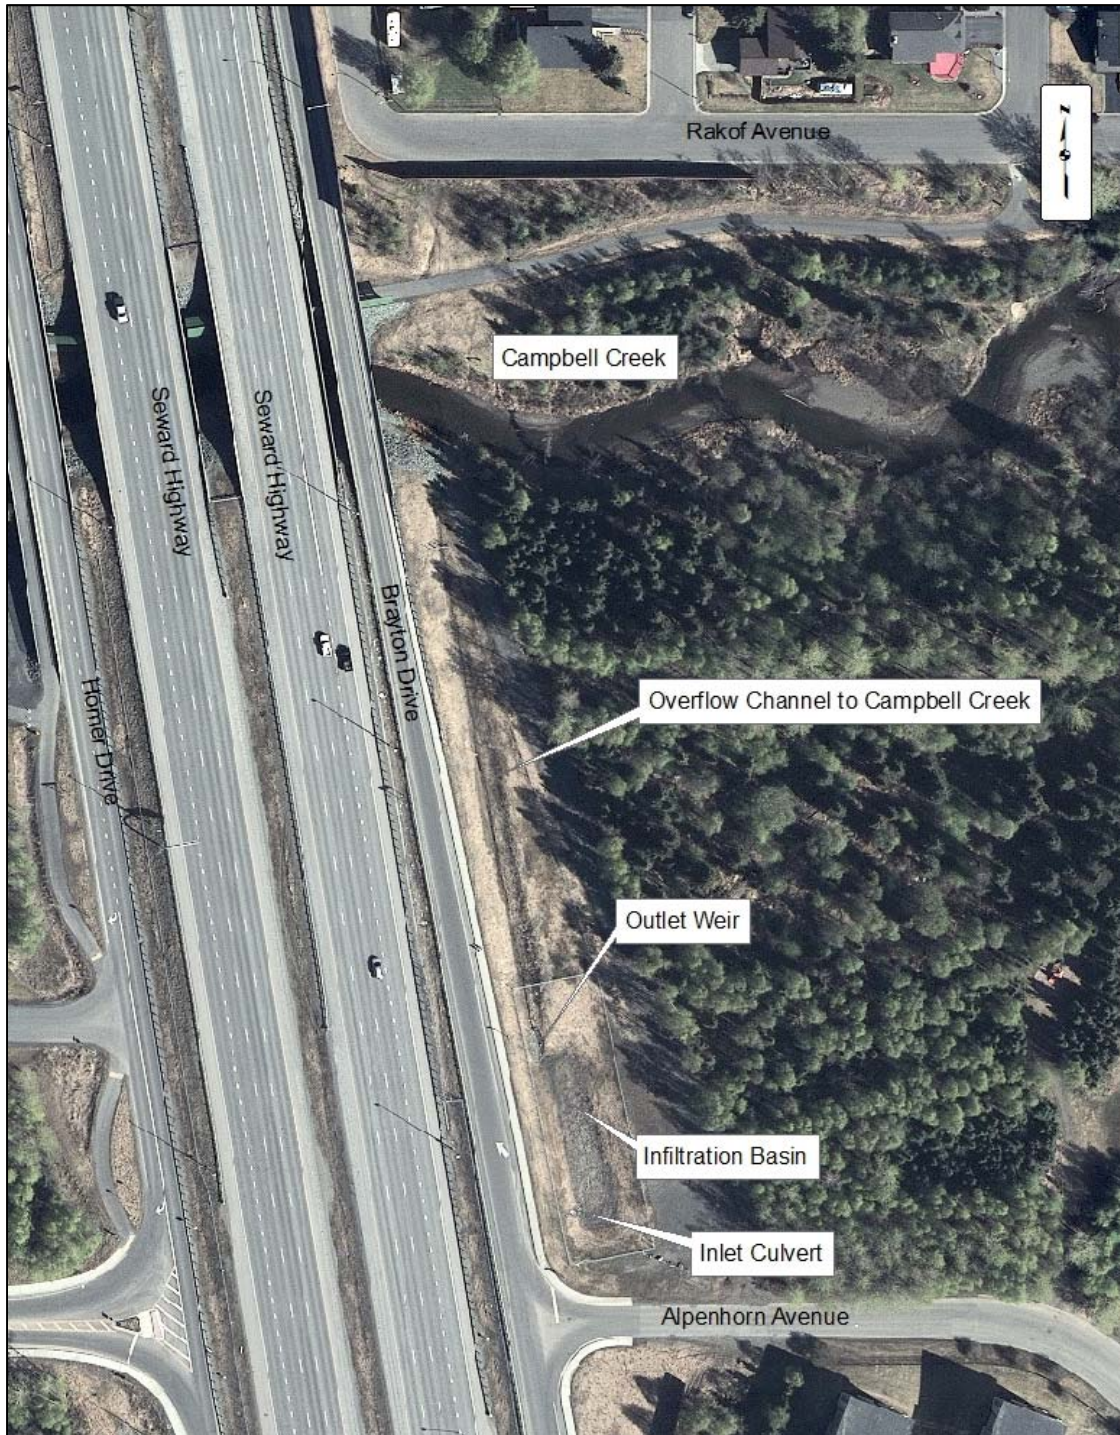
Figure 6: NSH Infiltration Basin Site Overview

2016 Observations. The September 22 observations indicate that this infiltration pond continues to perform very well. The inlet was flowing and standing water was observed in the pond, but the water surface elevations were well below the pond outlet elevation. Water is being captured, infiltrated, and treated for small and mid-size rain events, and the facility is exceeding its design capacity of 0.52 inches of rain. The inlet and outlet weirs that were placed during the 2013 monitoring program were still in place. Photos from the September 2016 site visit is provided in Figure 7 below.

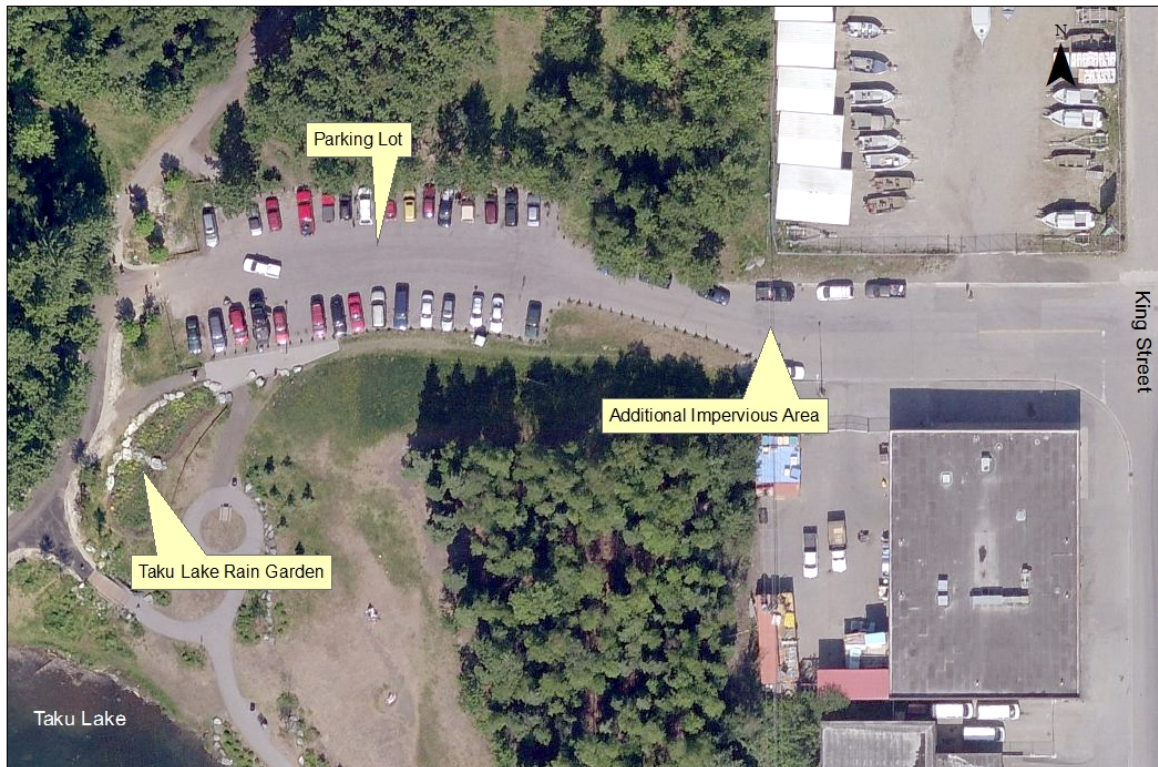
Figure 8: Taku Lake Rain Garden Site

2016 Observations. The September 22 observations continue to show that the rain garden is performing well. Water was observed to be flowing into the rain garden from the upstream impervious areas and a small amount of ponding was observed near the surface flow inlet. There was no standing water observed in the rain garden. The outlet pipe was flowing slowly, with water pooling downstream of the outlet and slowing the outlet flow velocities. The observations indicate that the rain garden is still providing successful retention of small rain events, and detention and water quality treatment for larger rain events. Vegetation in the rain garden is well established, and native vegetation is present in addition to planted species. Photos from the September 22 site visit are provided in Figure 9.

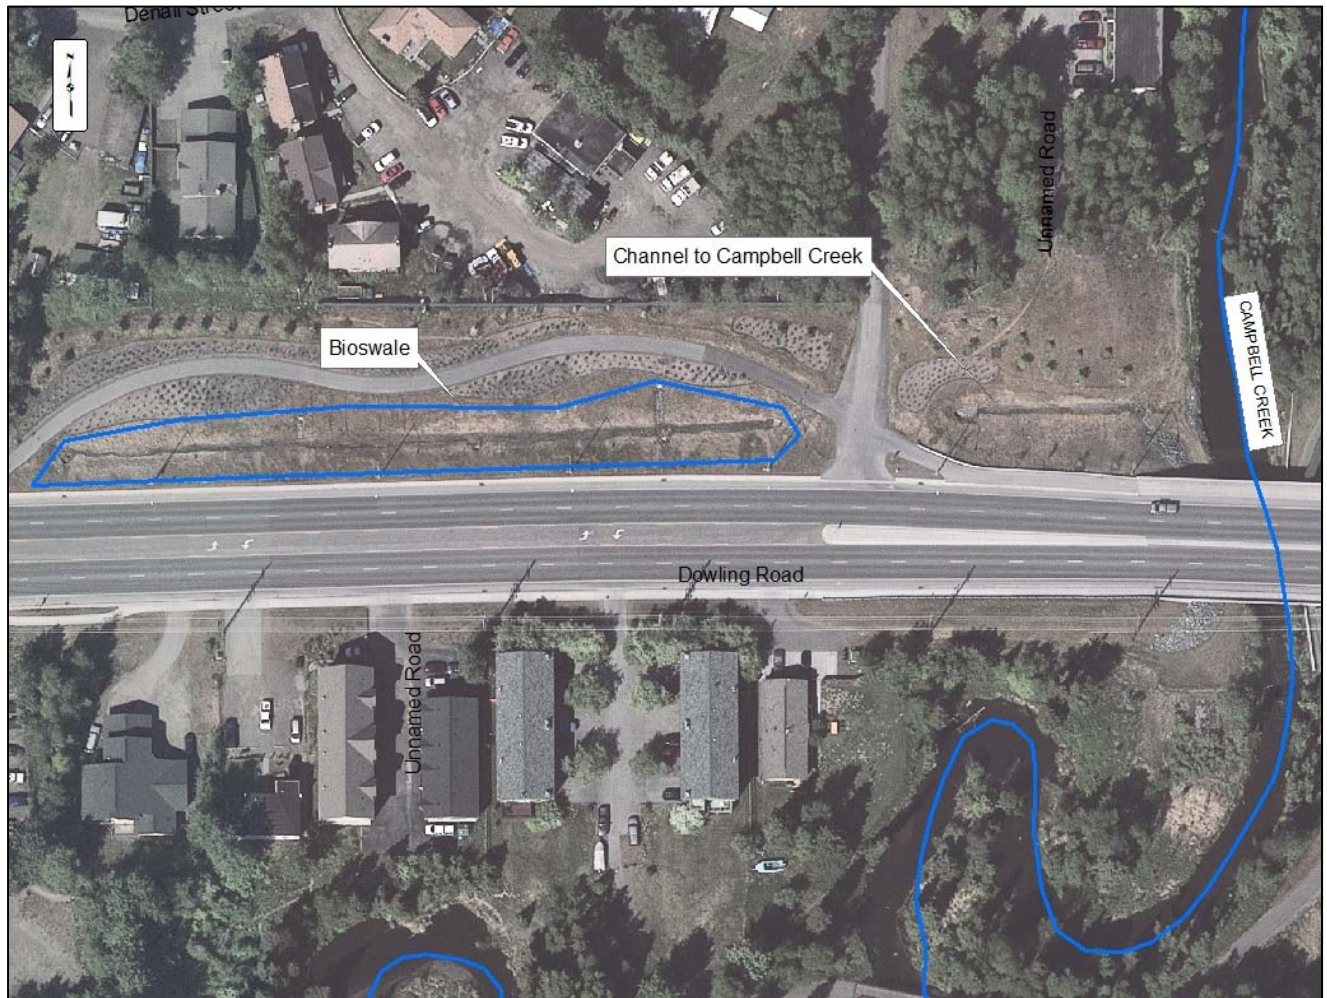
Figure 10: West Dowling Bioswale Site Overview

2016 Observations. The September 22 observations show that this swale is still performing well. During the site visit, water was entering the swale from most of the incoming storm drain pipes and trickling slowly toward the facility outlet. Previous years' monitoring reports have noted that vegetation in the swale was mowed fairly short, and it was noted that performance of the swale would likely be enhanced by letting the vegetation become more established. This year, the vegetation along the swale bottom was not mowed. The longer branches of grass provided additional slowing of the flow through the swale, and it is expected that improved treatment and peak flow attenuation were achieved. Photos from the September 22 site visit are provided in Figure 11.
