SUBJECT: APDES Inspection of ANC Taxilanes E1, E3 and E&G Reconstruction,
Authorization Number AKR10GP78, AKR10GP79

APDES INSPECTION REPORT

Name of Facility: ANC Taxilanes E1, E3 and E&G Reconstruction

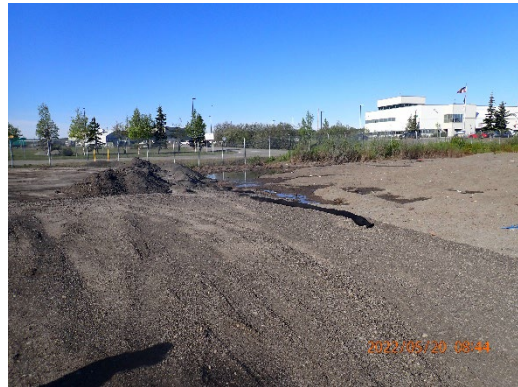
Photo 64

Comp Sock in Employee Parking

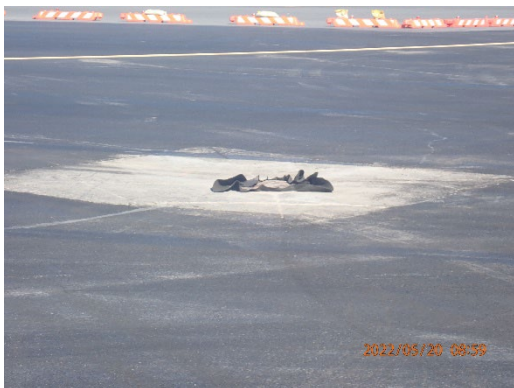
Photo 77

Witches Hat in Storm Water Grate

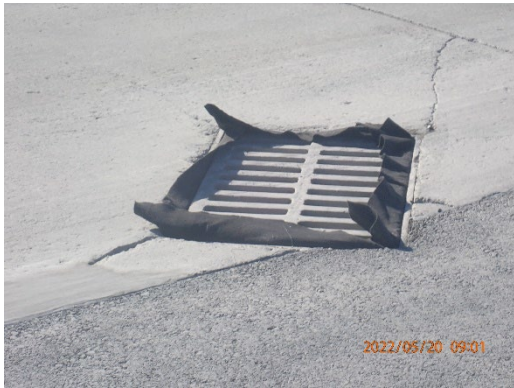
Photo 79

Witches Hat in Storm Water Grate

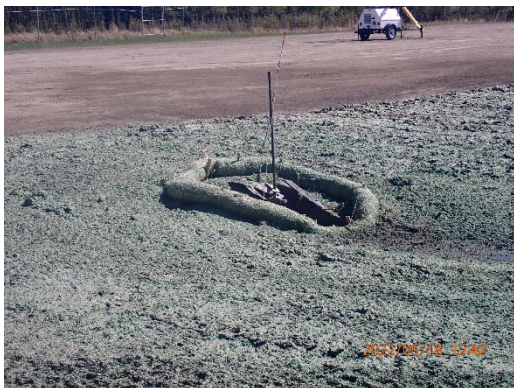
Photo 41

Straw Wattle Around Culvert

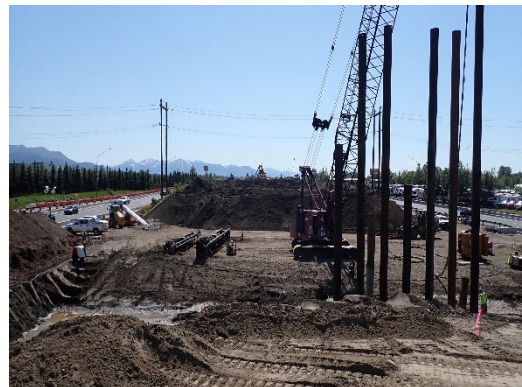
Photo 24

Overview of Seward Hwy bridge work
