SUBJECT: APDES Inspection of ANC Taxilanes E1, E3 and E&G Reconstruction,
Authorization Number AKR10GP78, AKR10GP79

APDES INSPECTION REPORT

Name of Facility: ANC Taxilanes E1, E3 and E&G Reconstruction

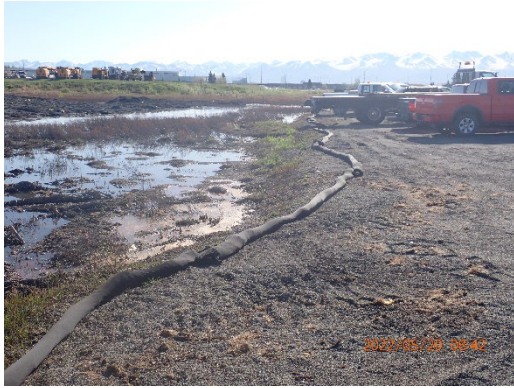
Photo 61

Comp Sock in Employee Parking

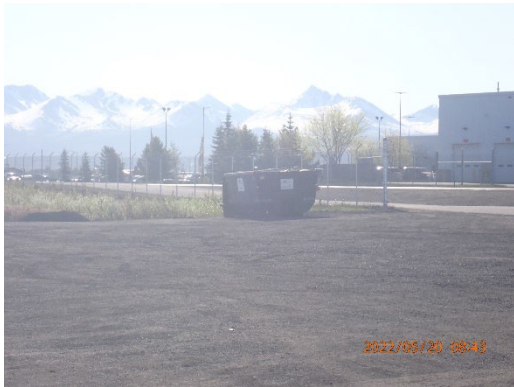
Photo 63

Dumpster for Debris

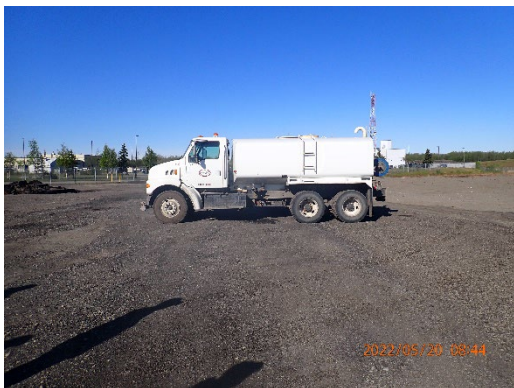
Photo 65

Water Truck

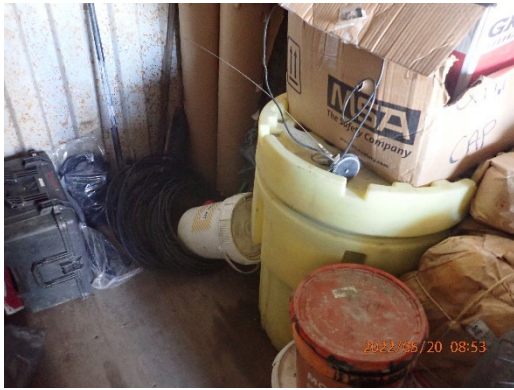
Photo 73

Spill Kits

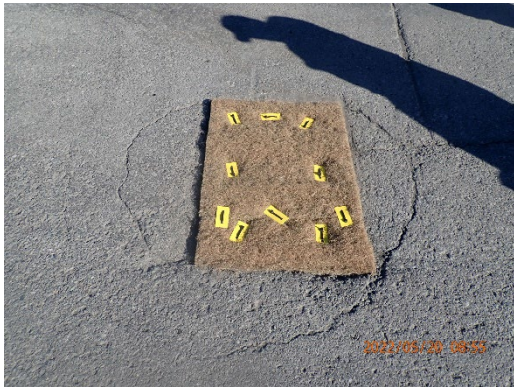
Photo 75

Boars Hair Inlet Protection

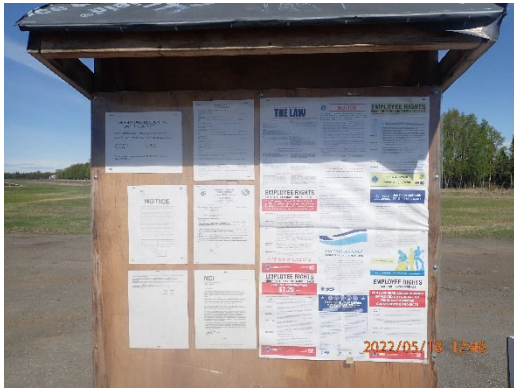
Photo 37

SWPPP Information Board

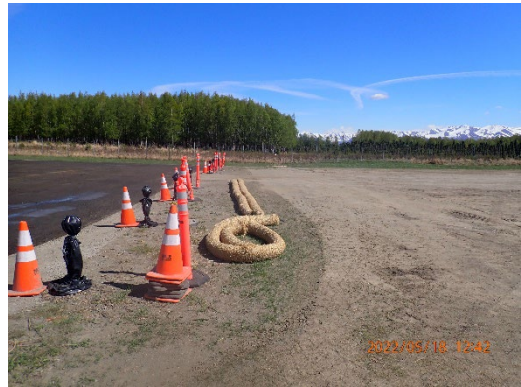
Photo 40

Spare BMPs

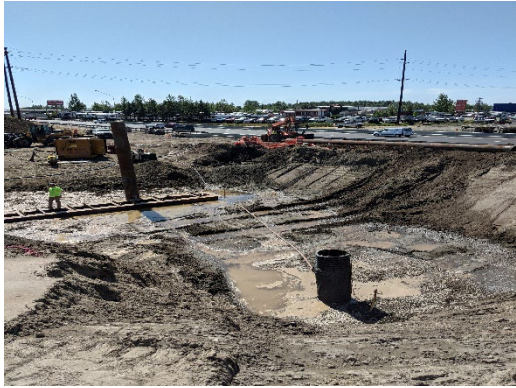
<p>Excavation bridge pilings installation area</p>	<p>Photo 26</p>

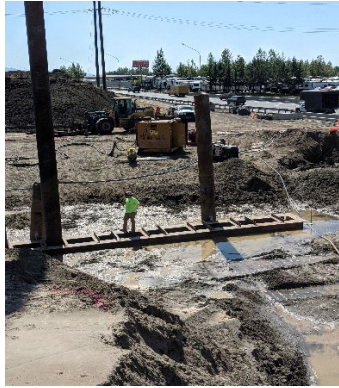
<p>Pilings metal template</p>
<p>Photo 27</p>

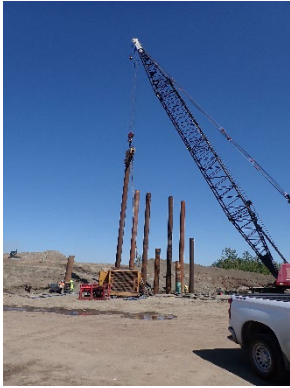
<p>Crane lowering in pilings to template</p>	<p>Photo 28</p>

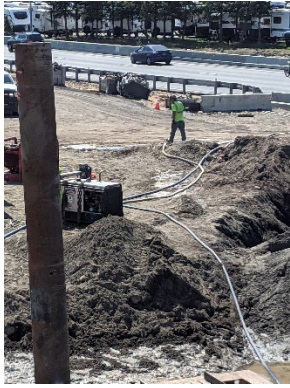
<p>Water hoses from excavation area</p>
<p>Photo 29</p>

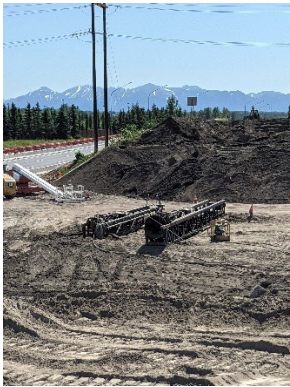
<p>Hammer equipment used to drive pilings</p>	<p>Photo 30</p>

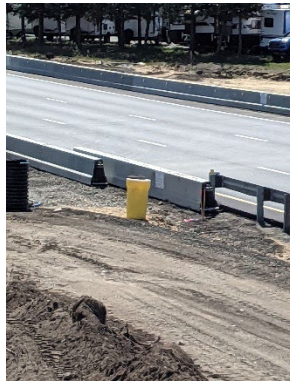
<p>Spill kit near excavation area</p>

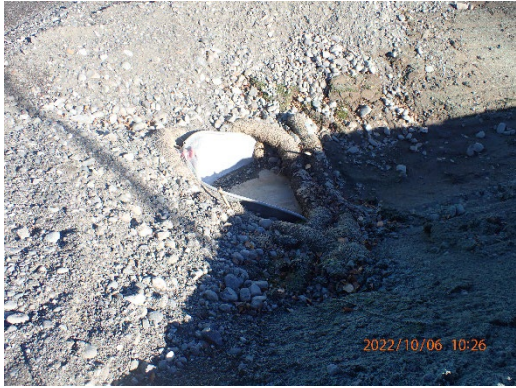
Straw Wattles At Culvert Entrances	Stream Crossing
Photo	Photo

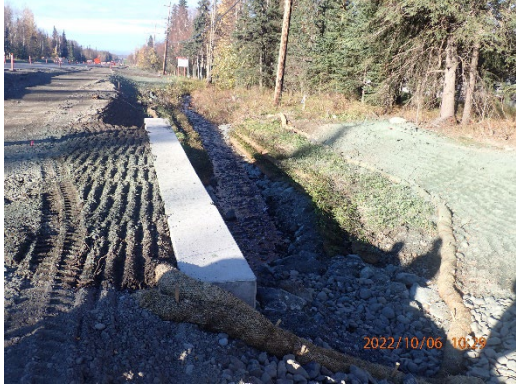
Stream Crossing Unser Road	Silt Fencing
Photo	Photo

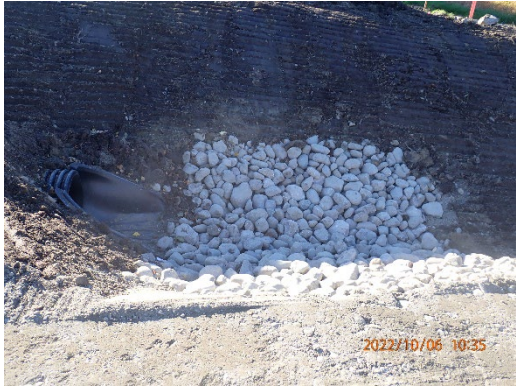
Velocity Dissipation Rocks	Cross Ditch Straw Wattles

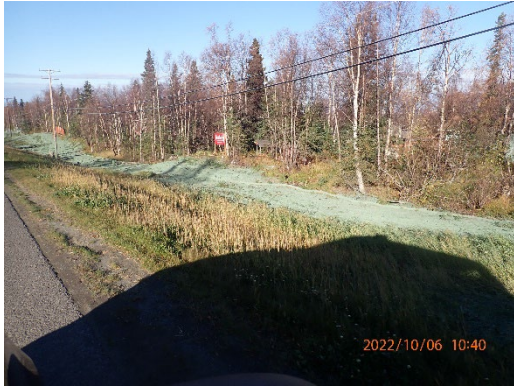
<p>A photograph showing a road with a green hydroseeded area. The green material is applied to the soil, and the road surface is visible in the foreground.</p> <p>2022/10/06 10:40</p>
Active Dirt work Section	Hydroseeding

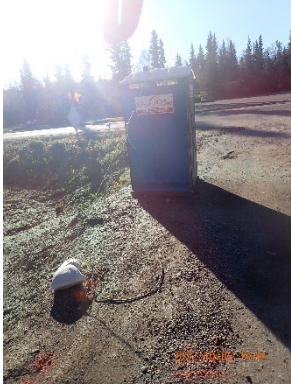
- It was noted during the inspection that a port-a-potty had not been strapped down to prevent tipping. It was remedied after the inspection, and a photo was submitted to show the correction.
- It was noted that a section of dirt work along the bank of a stream looked as if it could potentially partially erode under heavy rains and send sedimentation down the stream. However, no sedimentation or sediment transport was observed during the inspection. The section was stabilized to prevent potential issues.

<p>A photograph showing a blue port-a-potty secured with a lock. The port-a-potty is located on a dirt area next to a road.</p> <p>2022/10/06 10:44</p>
Hydroseeding	Secured Port-A-Potty

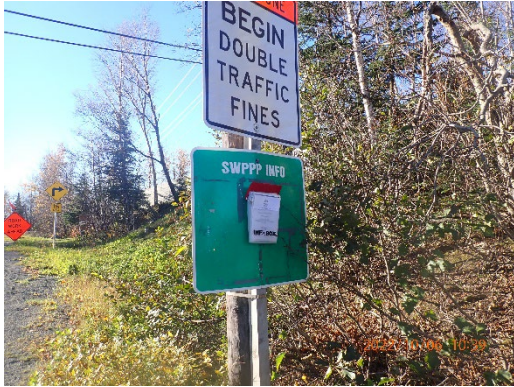
<p>A photograph showing a green SWPPP info board. The board is mounted on a post and contains information about the SWPPP. A sign above it reads "BEGIN DOUBLE TRAFFIC FINES".</p> <p>2022/10/06 10:54</p>
